# *United Utilities' SCaMP Project*

Monitoring the effects of upland habitat restoration on hydrology, water colour and carbon at three blanket bog sites

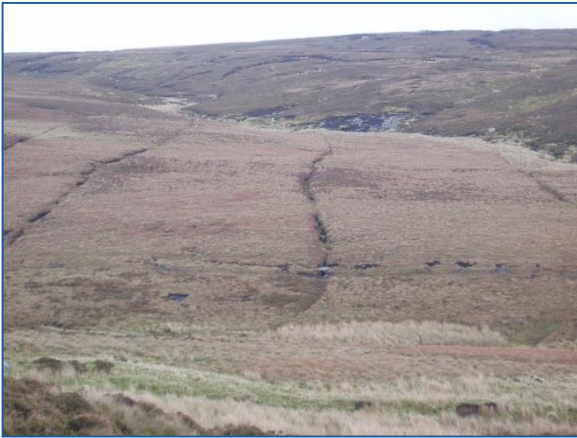
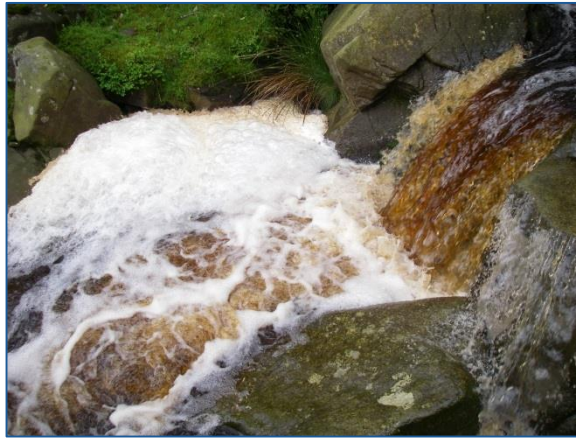
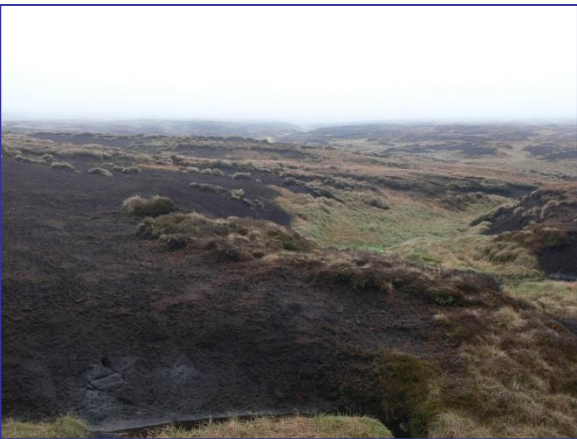
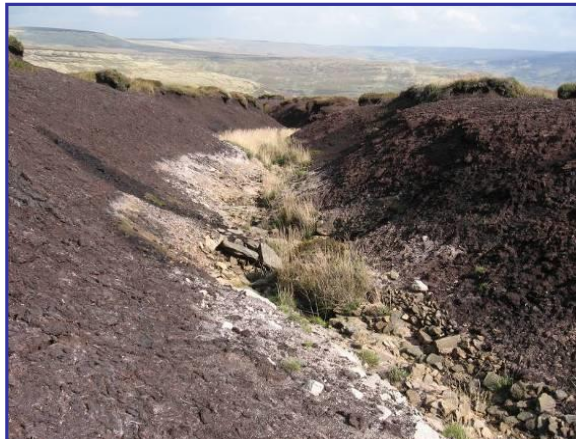
# *Prior to Restoration*

- Areas of extensive bare peat.
- Significant artificial drainage and gully erosion.
- Poor vegetation condition and loss of peat from the moorland.
- Effect of grazing and burning regimes over decades.

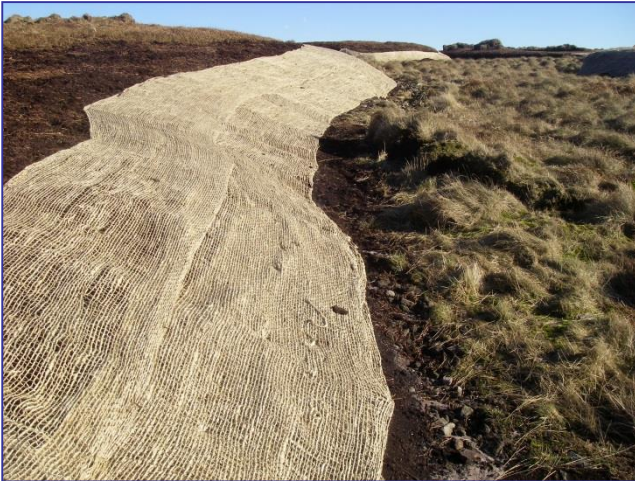
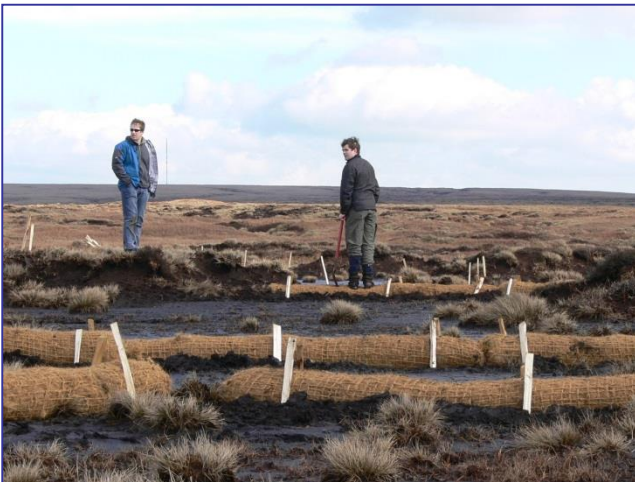
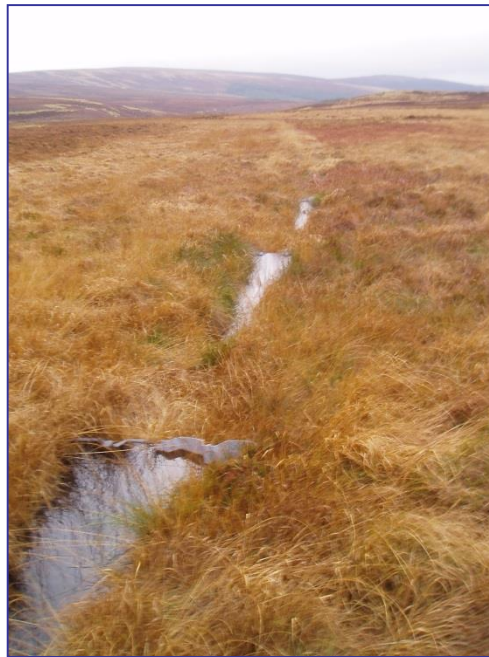
# Restoration Measures

Across 12,300ha blanket bog:

85km grips blocked with peat or plastic dams.

470ha eroding bare peat treated with 'nurse' crop, heather brash, geojute textile.

'novel' coir roll installation.

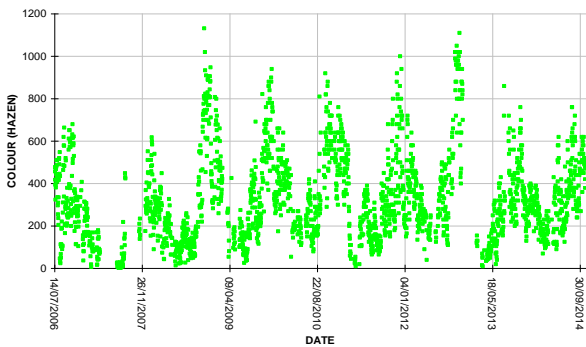
Ashway Gap Chew Clough - Raw Water Colour July 2006-Oct 2014

Extremely high colour levels in the degraded Longdendale catchments at Ashway Gap, where peak colour frequently exceeds 1200 hazen...

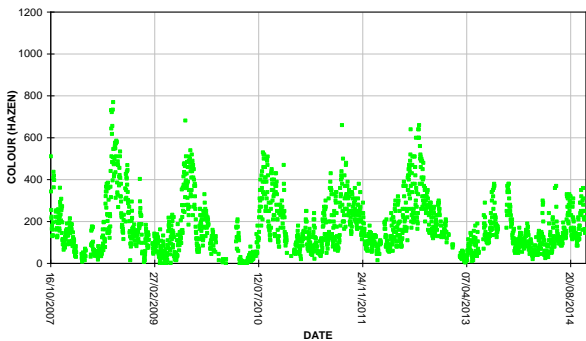
Brennard Bield Field Stream - Raw Water Colour 2007 - Oct 2014

moving down to Brennard (lower and less variable)...

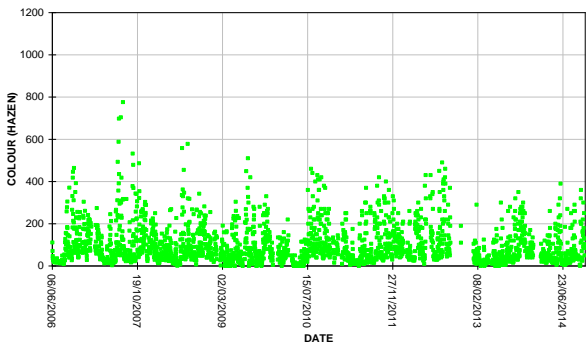
Goyt Upstream of Errword Reservoir - Raw Water Colour 2006 - Oct 2014

with the lowest colour levels and variation in the Goyt and Whitendale with peak colour at 400 hazen.

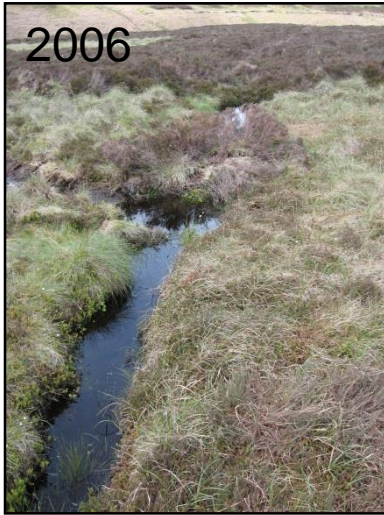
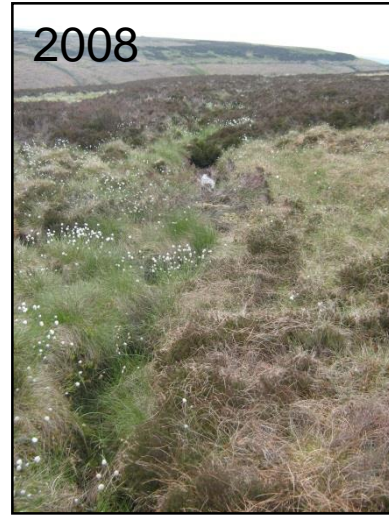
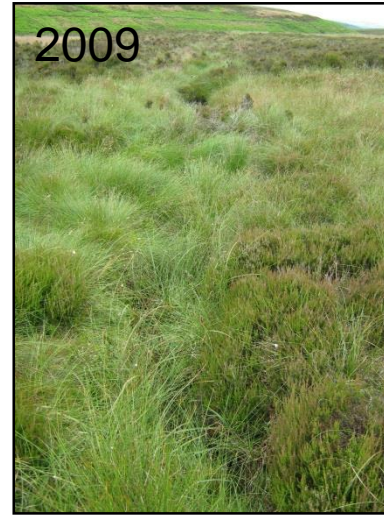
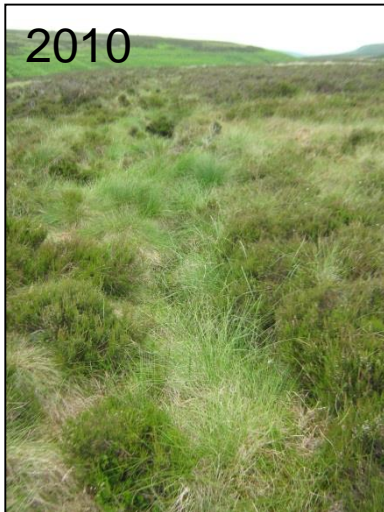
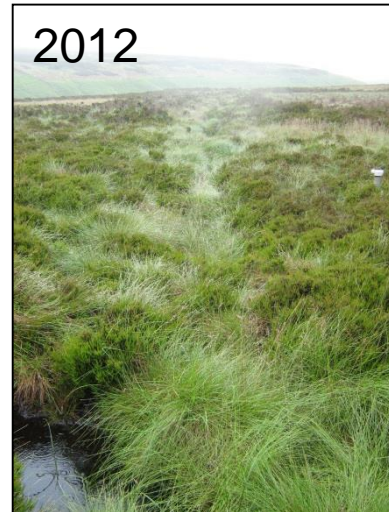
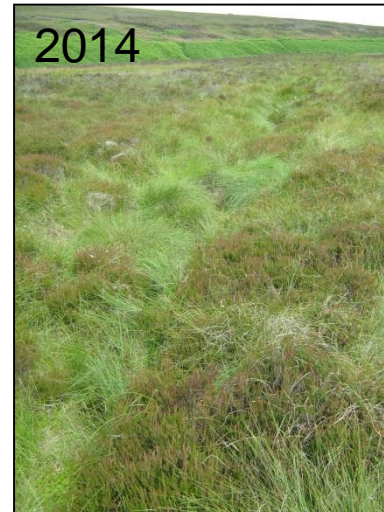
On [Goyt](#) (above Derbyshire Bridge) there is clearly visible evidence of the benefits of blocking grips.

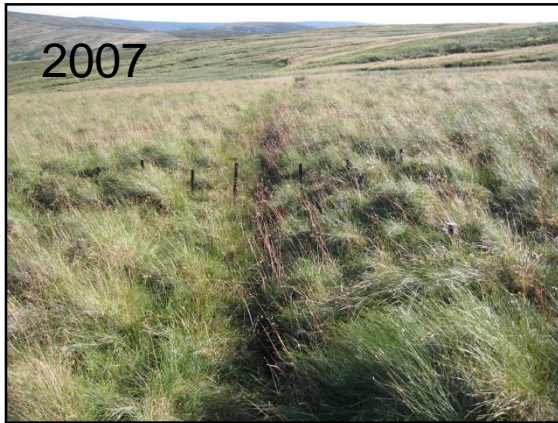
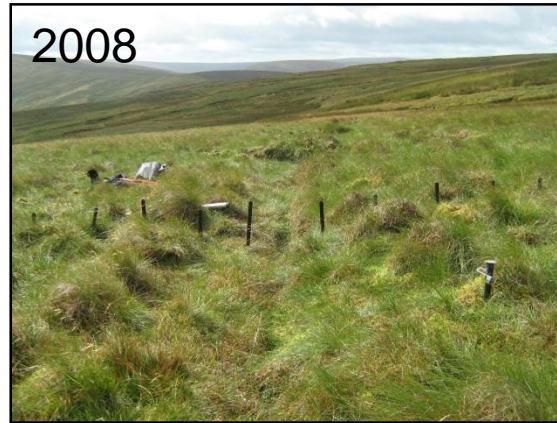
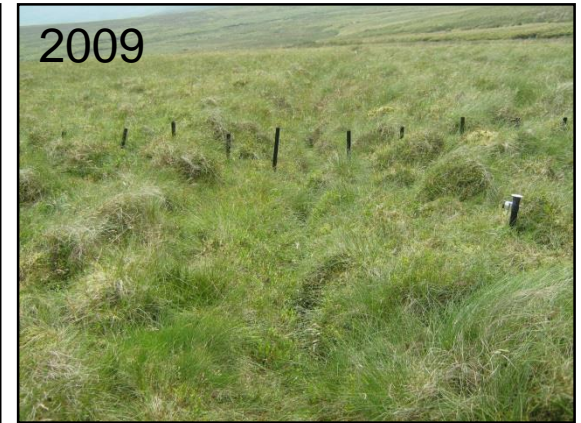
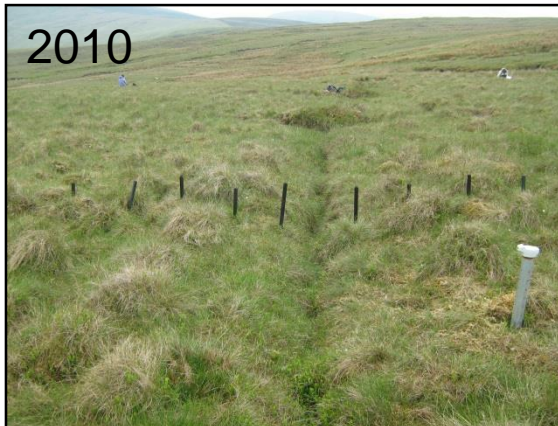
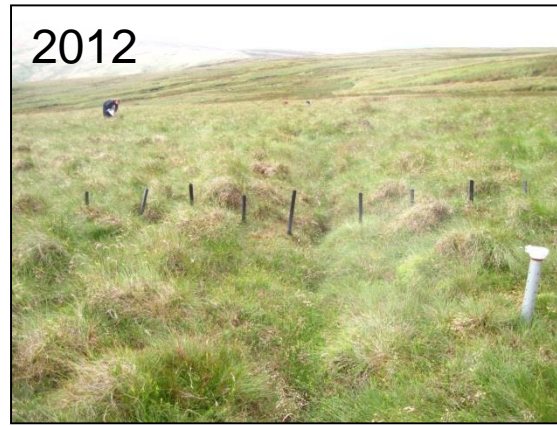
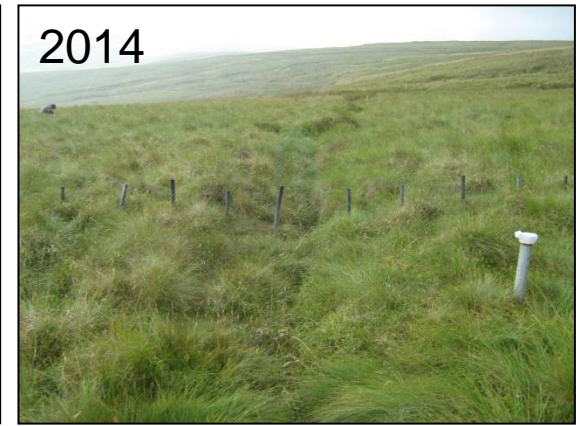
Many of the trends on well-vegetated blanket bog are difficult to detect through fixed point photography, but are still discernable – [Brennand](#) (Bield Field).

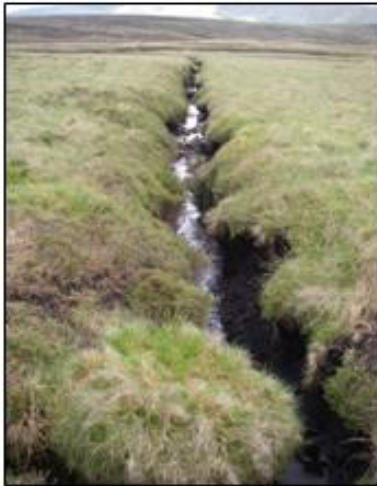
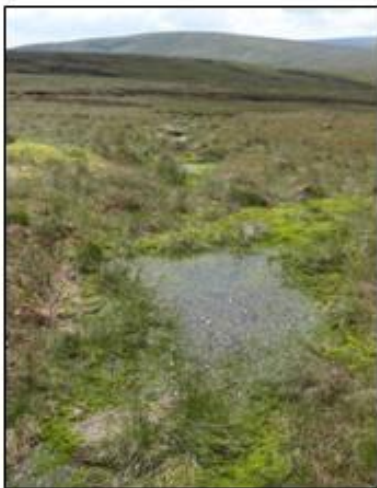
On [Brennand](#) (Brown Syke) there is also visible evidence of the benefits of blocking grips, even on large drains/grips.

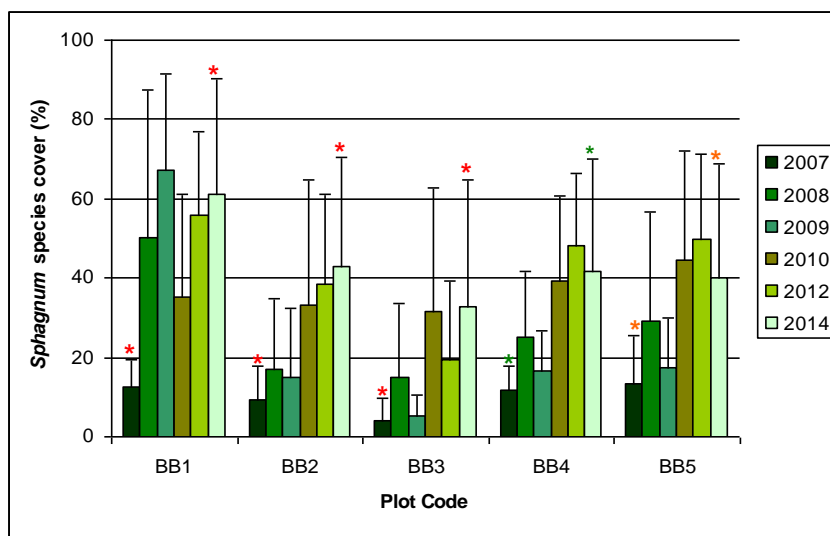
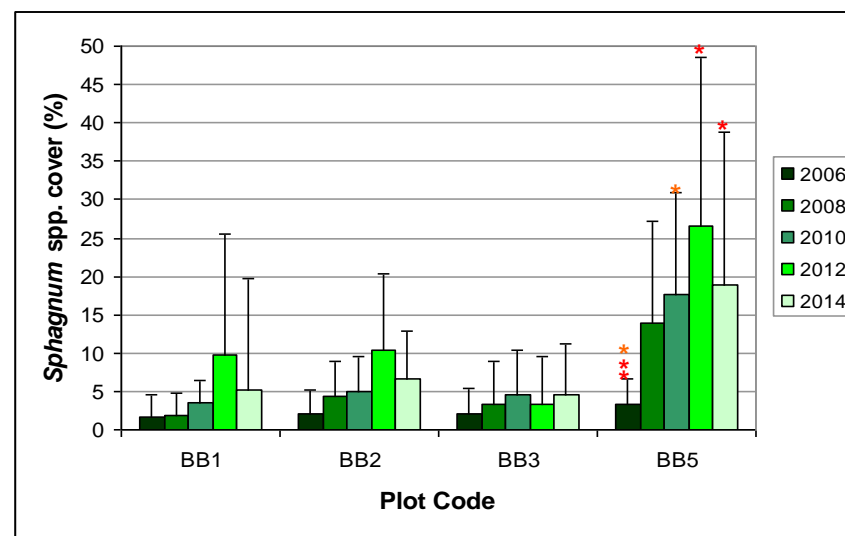
Significant increases in *Sphagnum* cover: **Brennand** (L) & **Goyt** (R)

- BB1 = no grips
- BB2 – BB5 = grips blocked 2010, peat
- 2007 = baseline
- 2008 = grazing changed, grips not blocked
- 2009 – 2012 = post blocking

- BB1 & BB2 = grips blocked 2006, peat
- BB3 = grips blocked 2010, peat
- BB5 = grips blocked 2006, peat & plastic

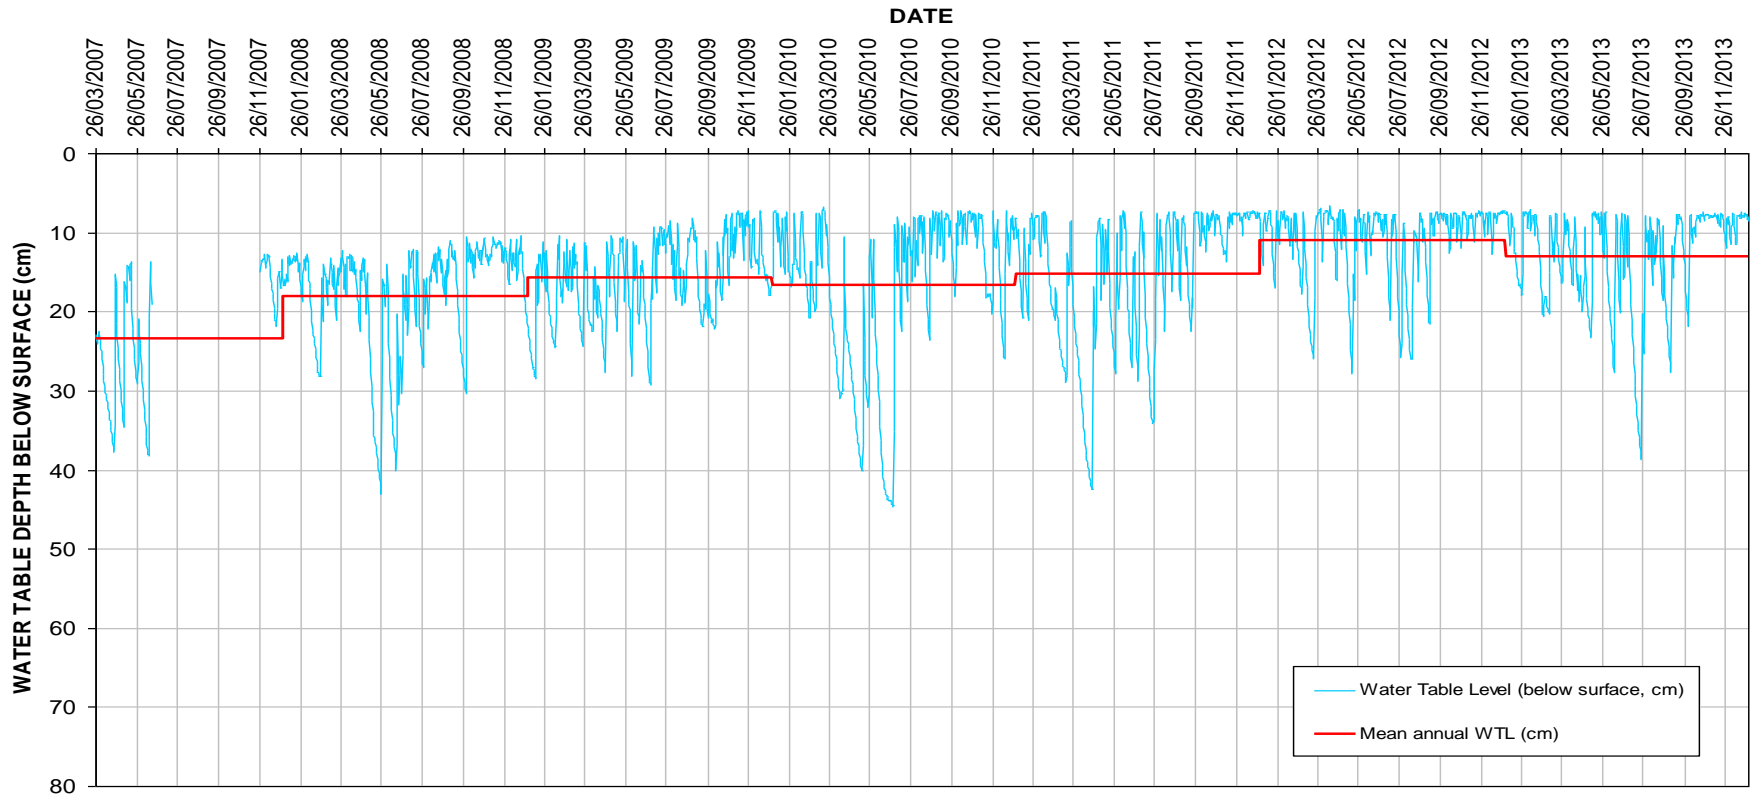
Consistent trend towards higher and more stable **peat water levels** over time at **Goyt** (Dipwell 1 Raven's Clough) mean annual trend line (2006-2014).

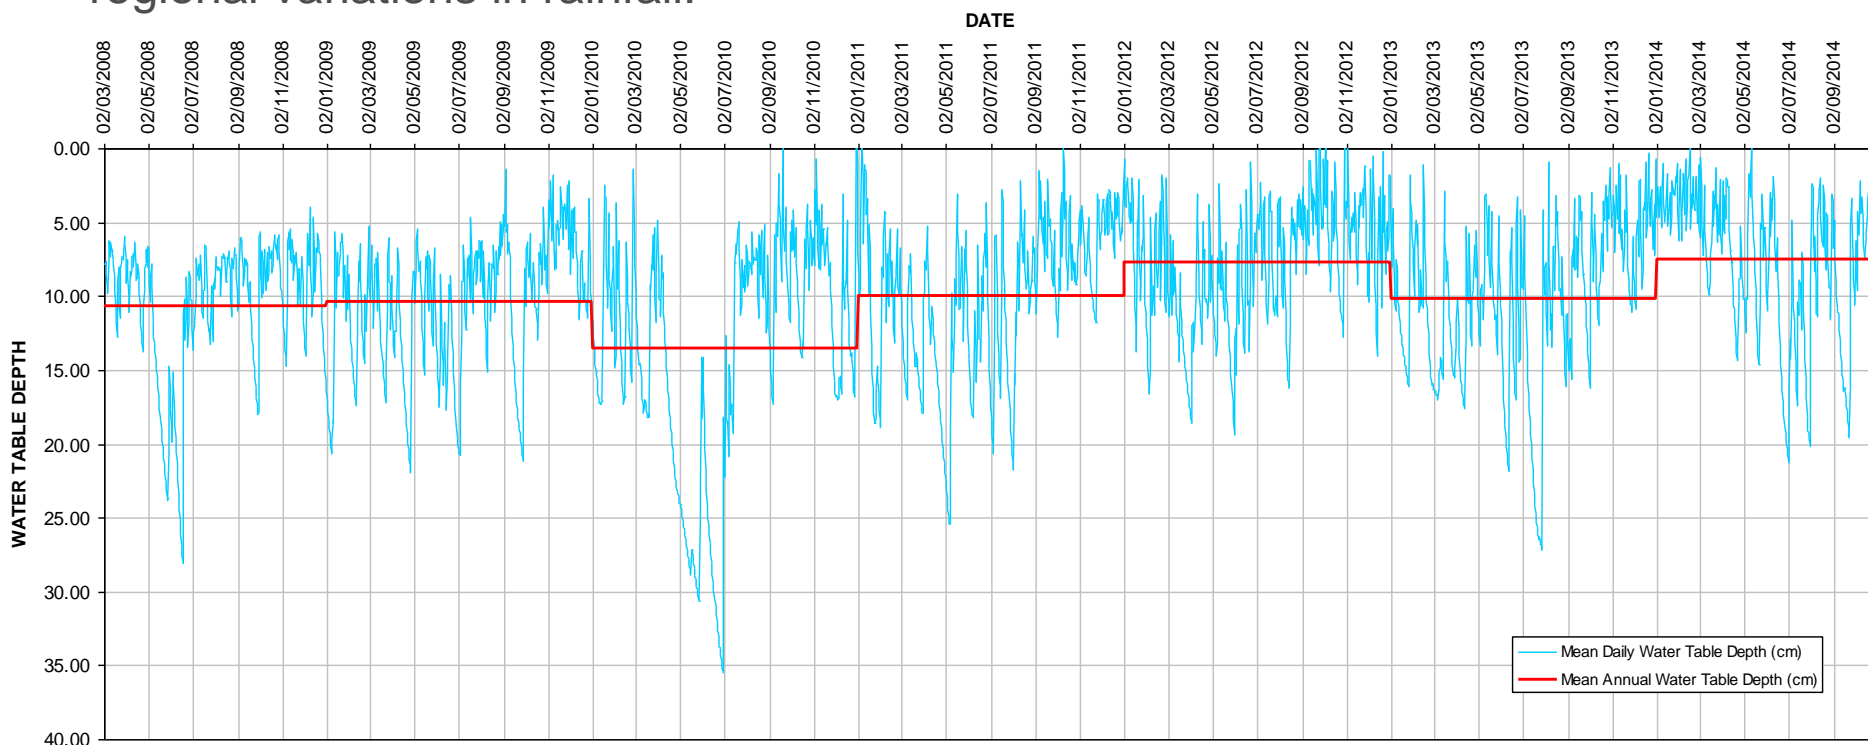
Peat water levels show similar results at [Whitendale](#), with general trend towards increasing annual mean, although some variation over time due to regional variations in rainfall.

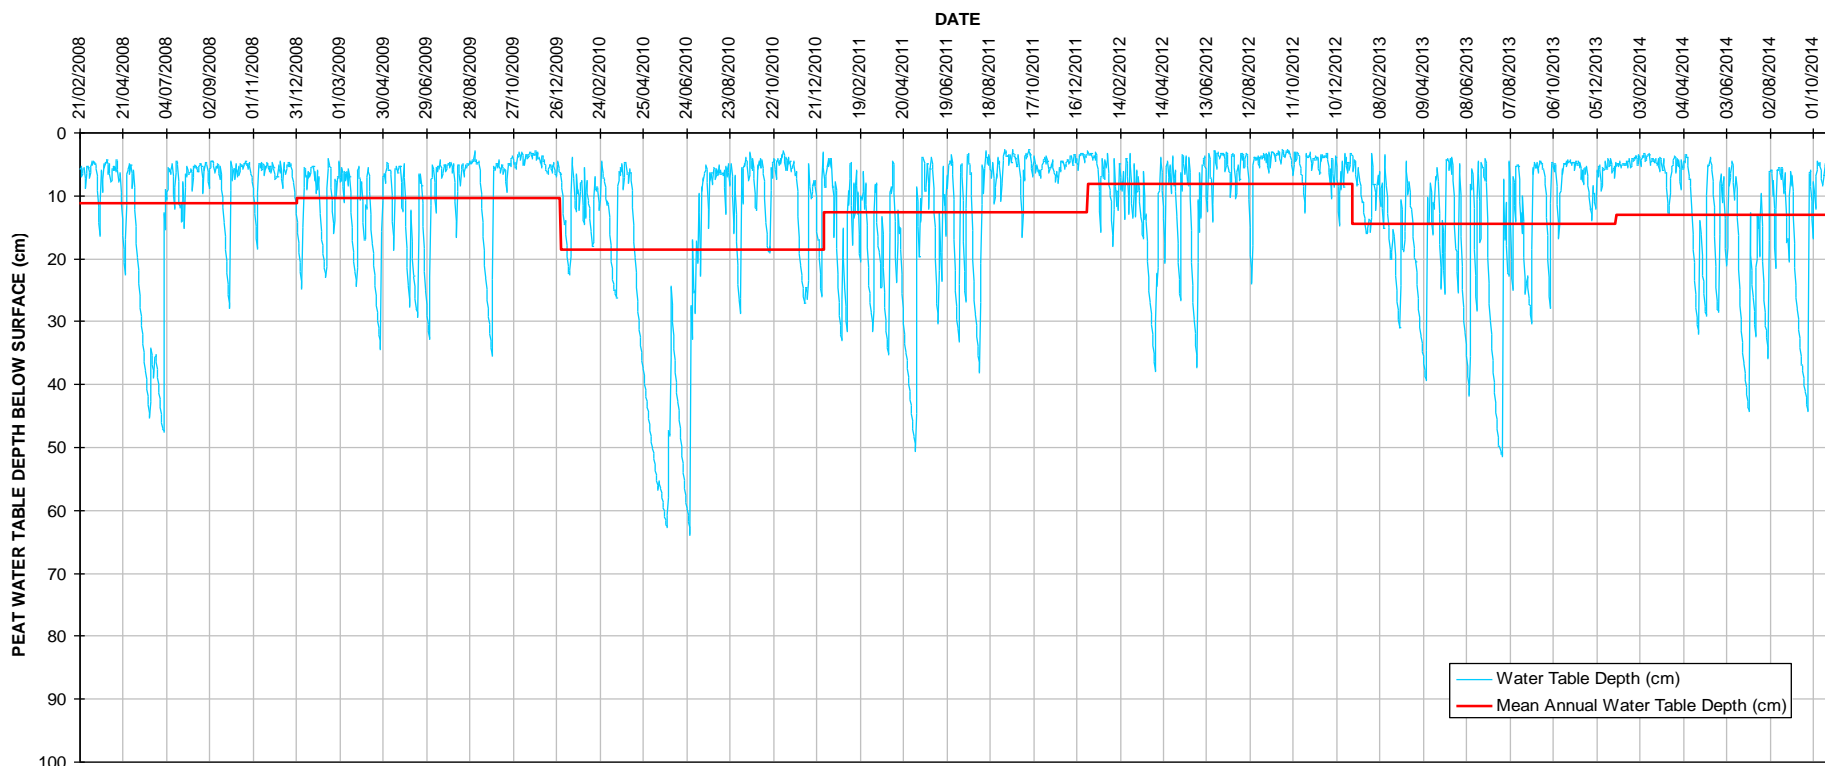
Peat water levels show similar results at **Brennand** (Dipwell 3 – Bield Field) as seen at Whitendale with general trend towards increasing annual mean, but some variation over time possibly related to local rainfall patterns.

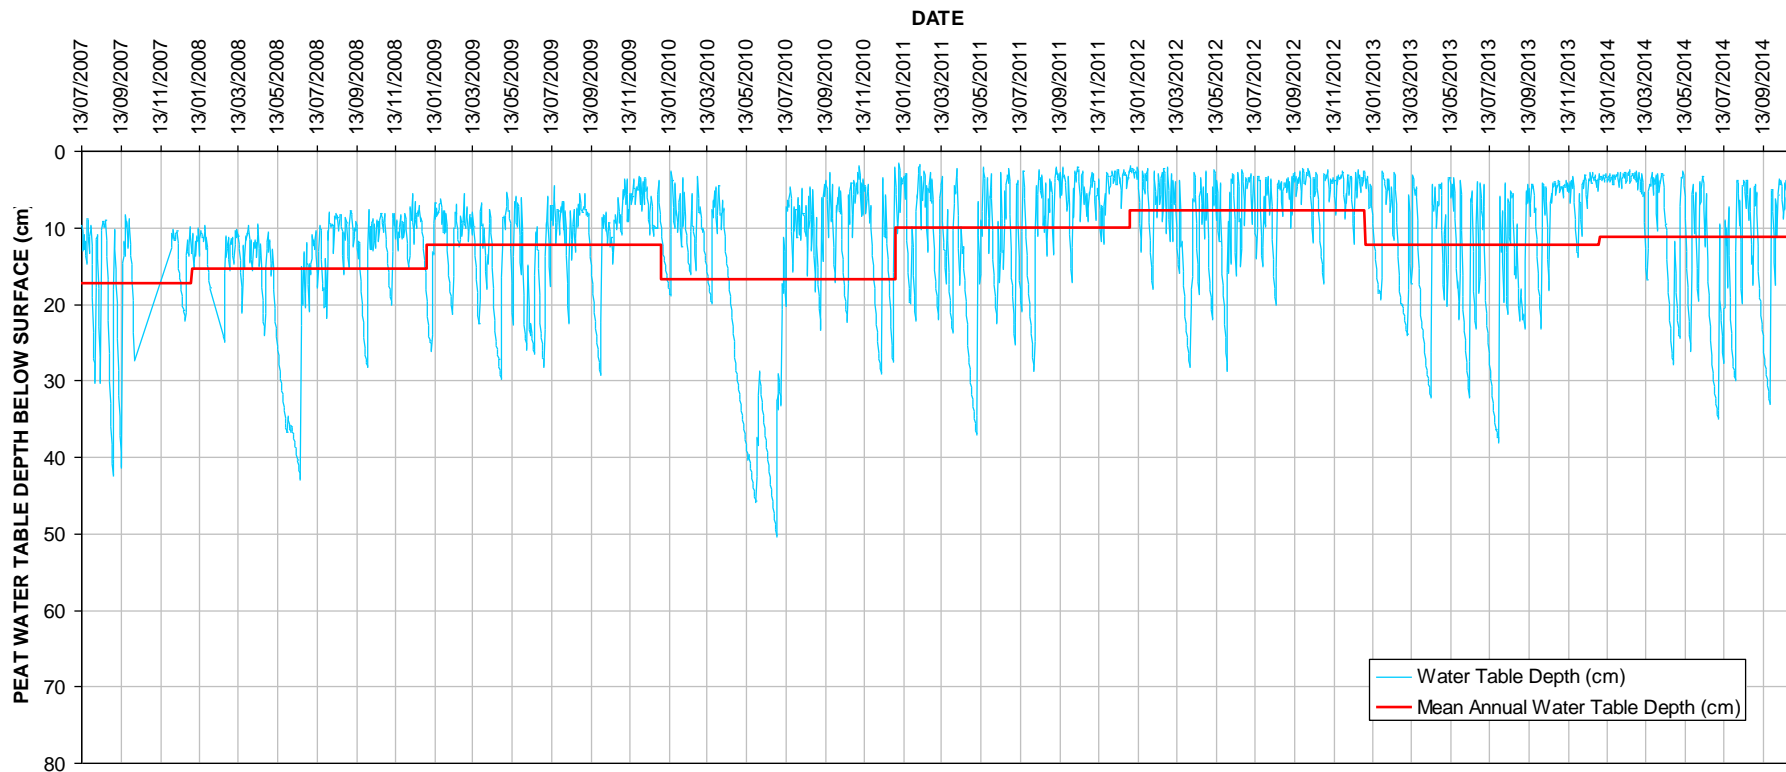
Peat water levels show similar results at **Brennand** (Dipwell 2 Brown Sykes), with general trend towards increasing annual mean.

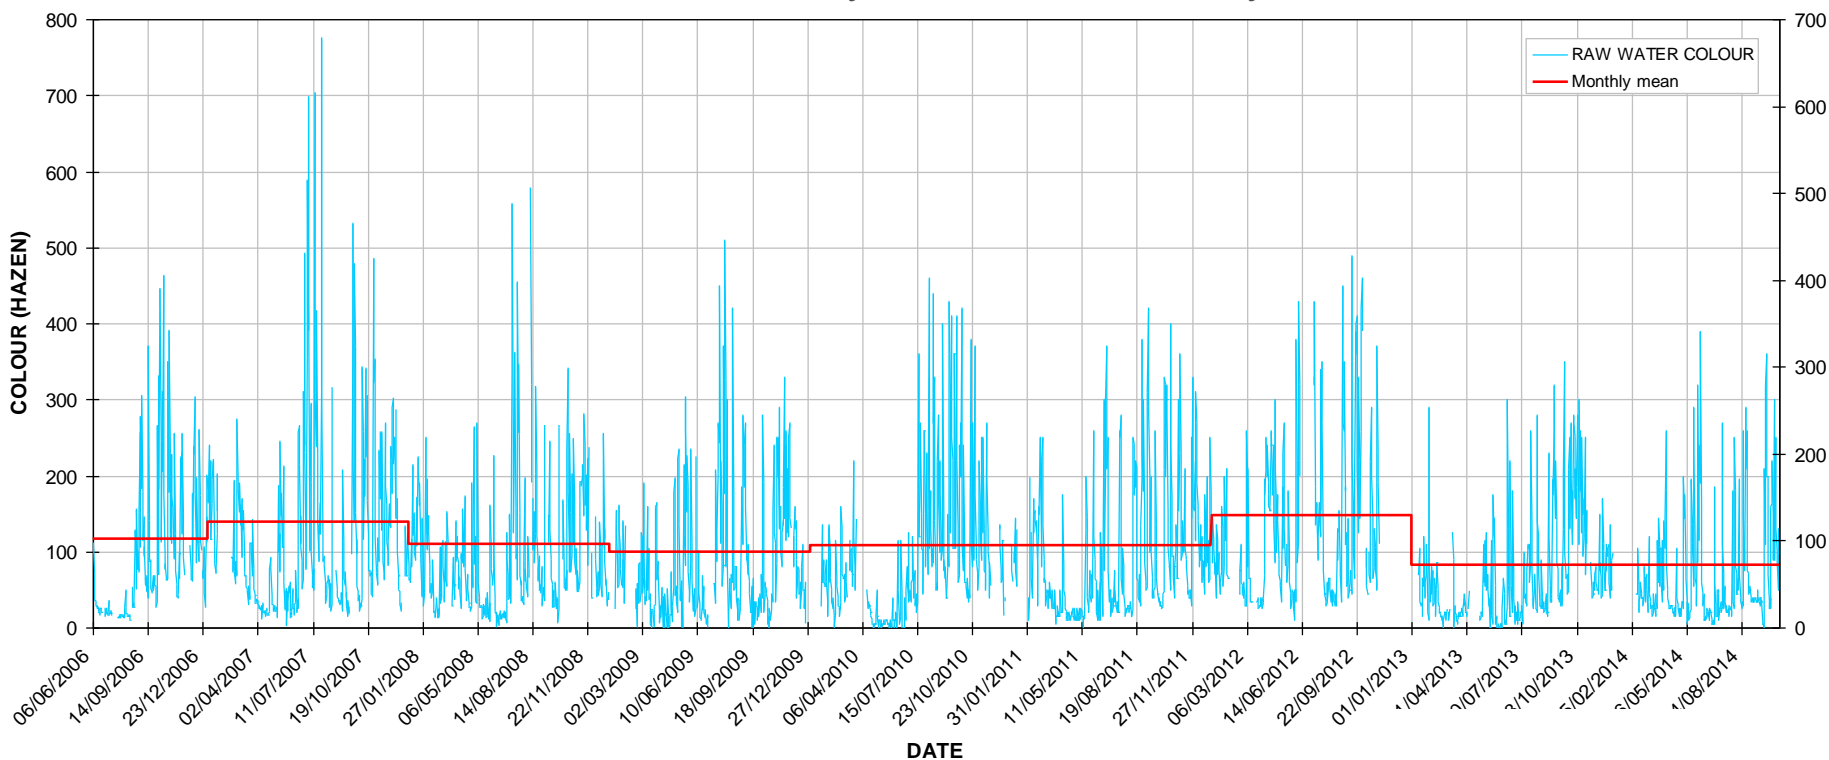
Small but significant reductions in raw water **colour** over time – Goyt (below) & Brennand show similar trends, notably reduced variability

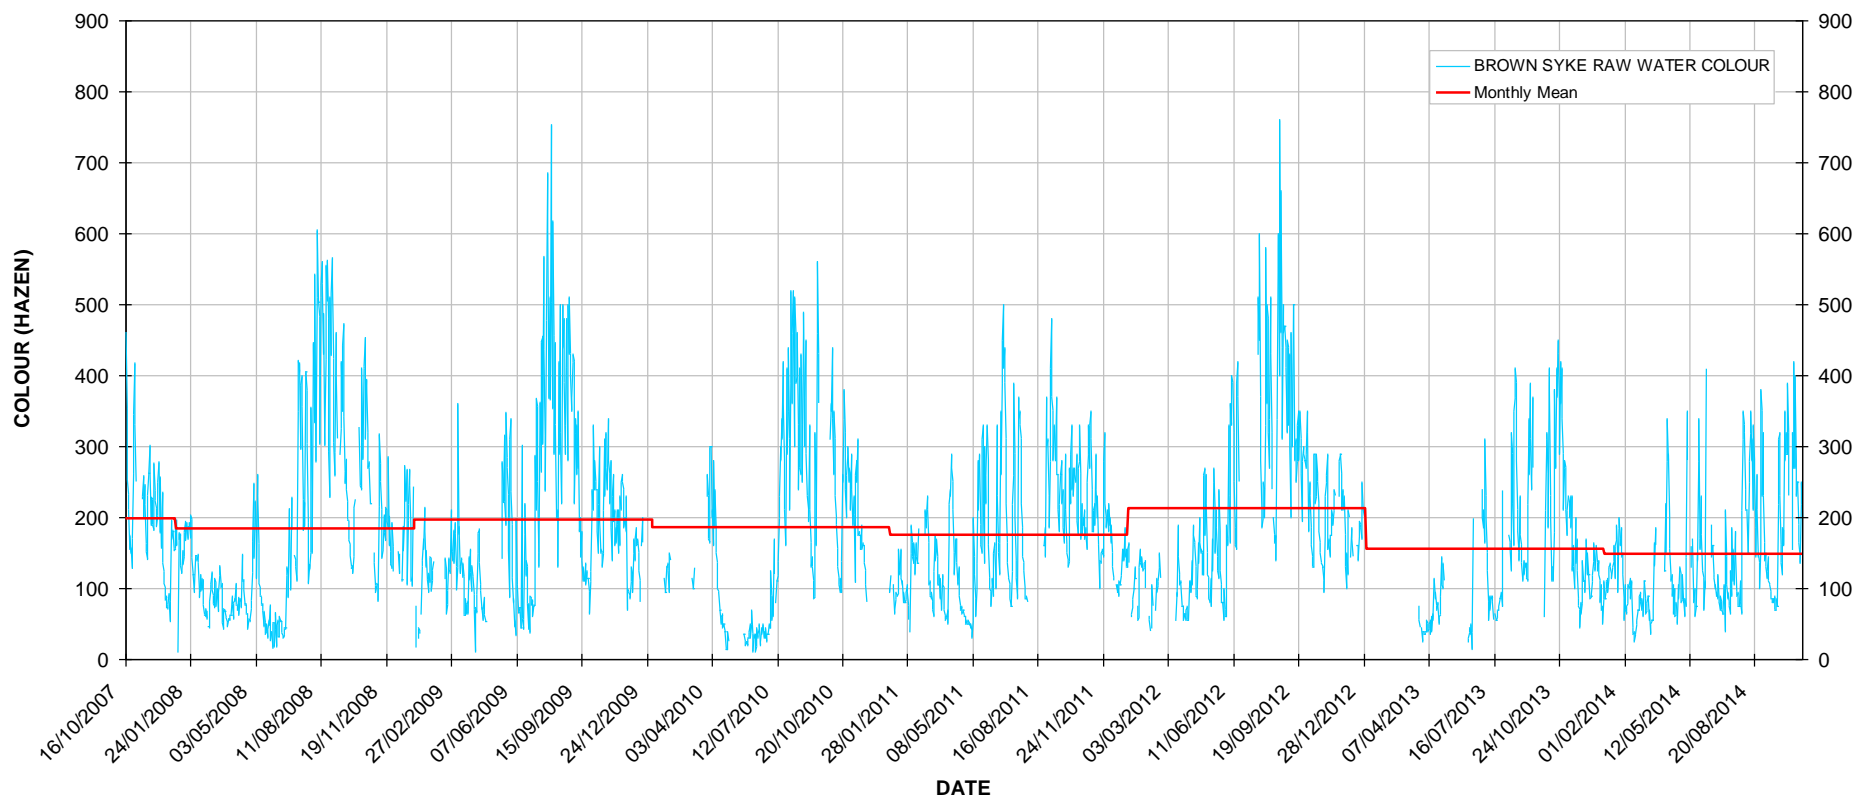
Similar reduction in **raw water colour** values and variability over time at **Brennard** (Brown Syke), note higher values compared to Goyt

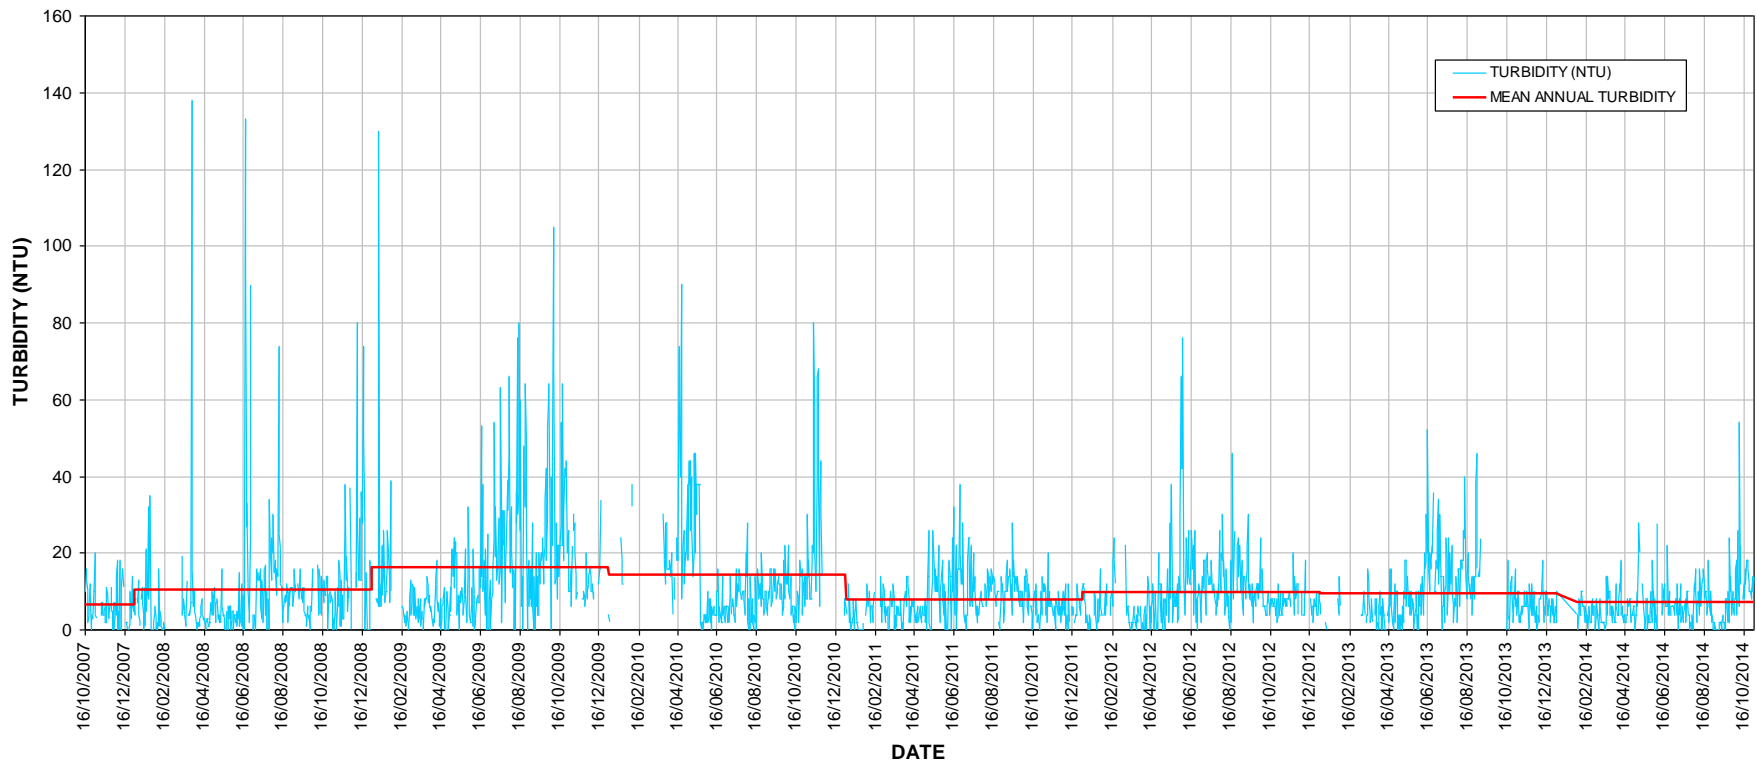
More or less stable raw water **turbidity Brennand** (Brown Syke) reduced to a practical minimum, with variation reducing over time. Similar across all sites.

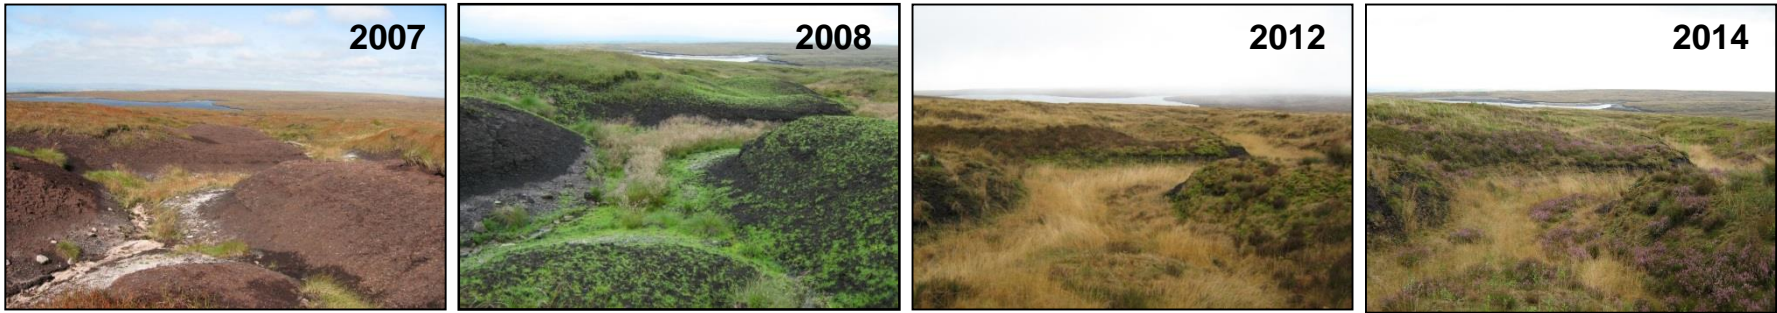
- Ashway Gap BB1 = mounds of bare peat with lime, 'nurse' grass seed and fertiliser (LSF)

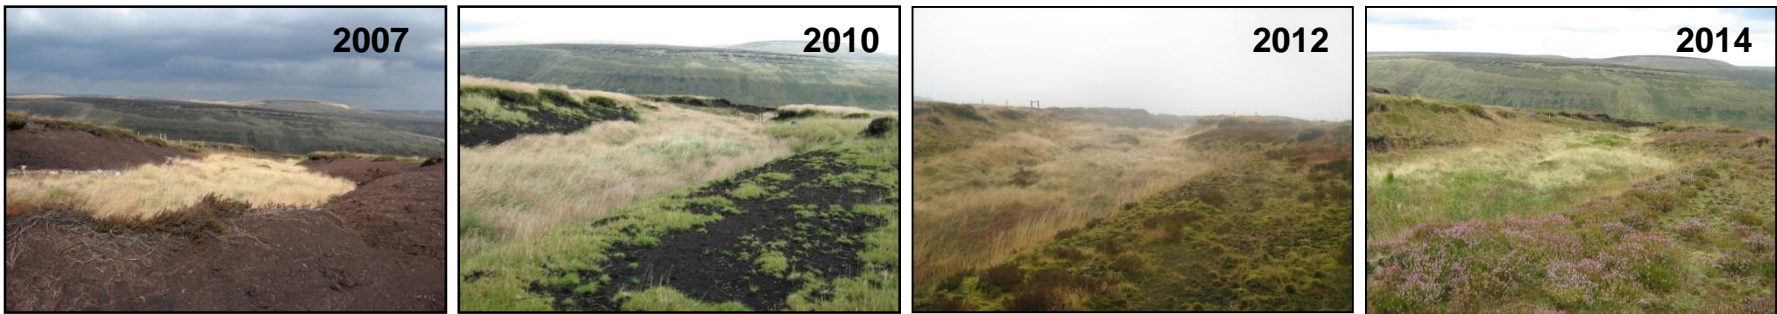
- Quiet Shepherd BB6 = bare peat slopes with LSF, brash (a – geojute; b + geojute)

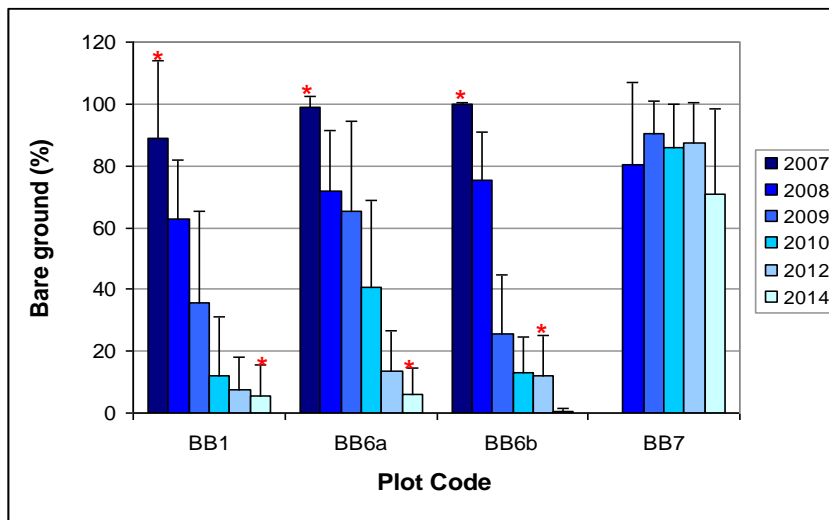
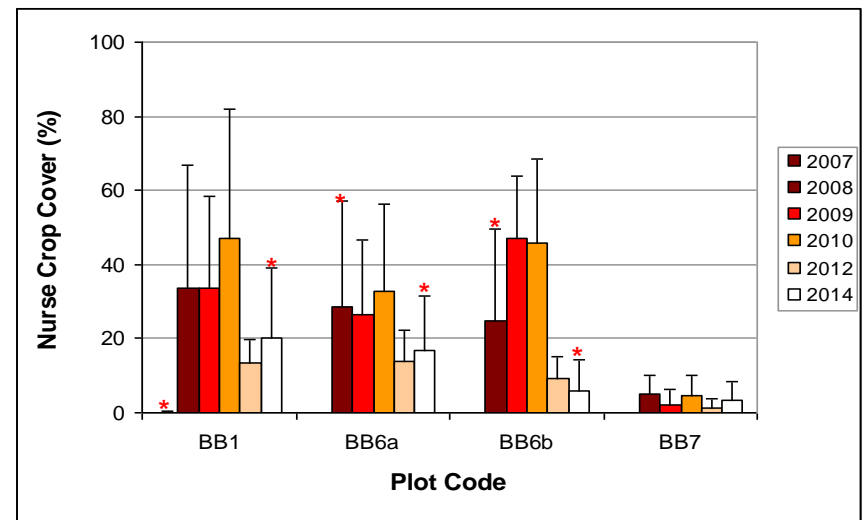
Significant decrease in bare ground across treated plots on North Longdendale (L). Nurse crop (largely Highland bent, *Agrostis castellana*) establishes quickly then reduces in cover (R).

- BB1 = mounds of bare peat with lime, 'nurse' grass seed and fertiliser (LSF)
- BB6 = bare peat slopes with LSF, brash (a – geojute; b + geojute)
- BB7 = untreated bare peat slopes

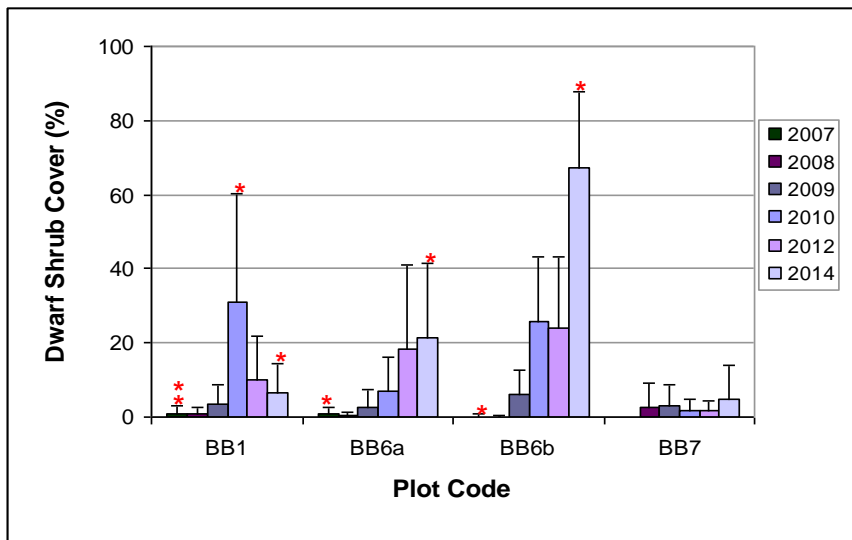
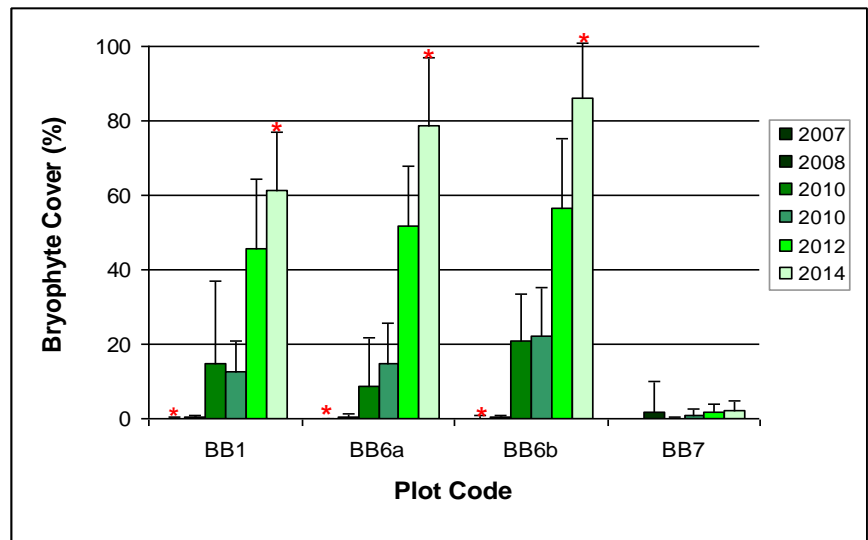
Dwarf shrubs (largely heather, *Calluna vulgaris*) begin to establish.  
Along with mosses *Campylopus introflexus* and *Hypnum jutlandicum*.

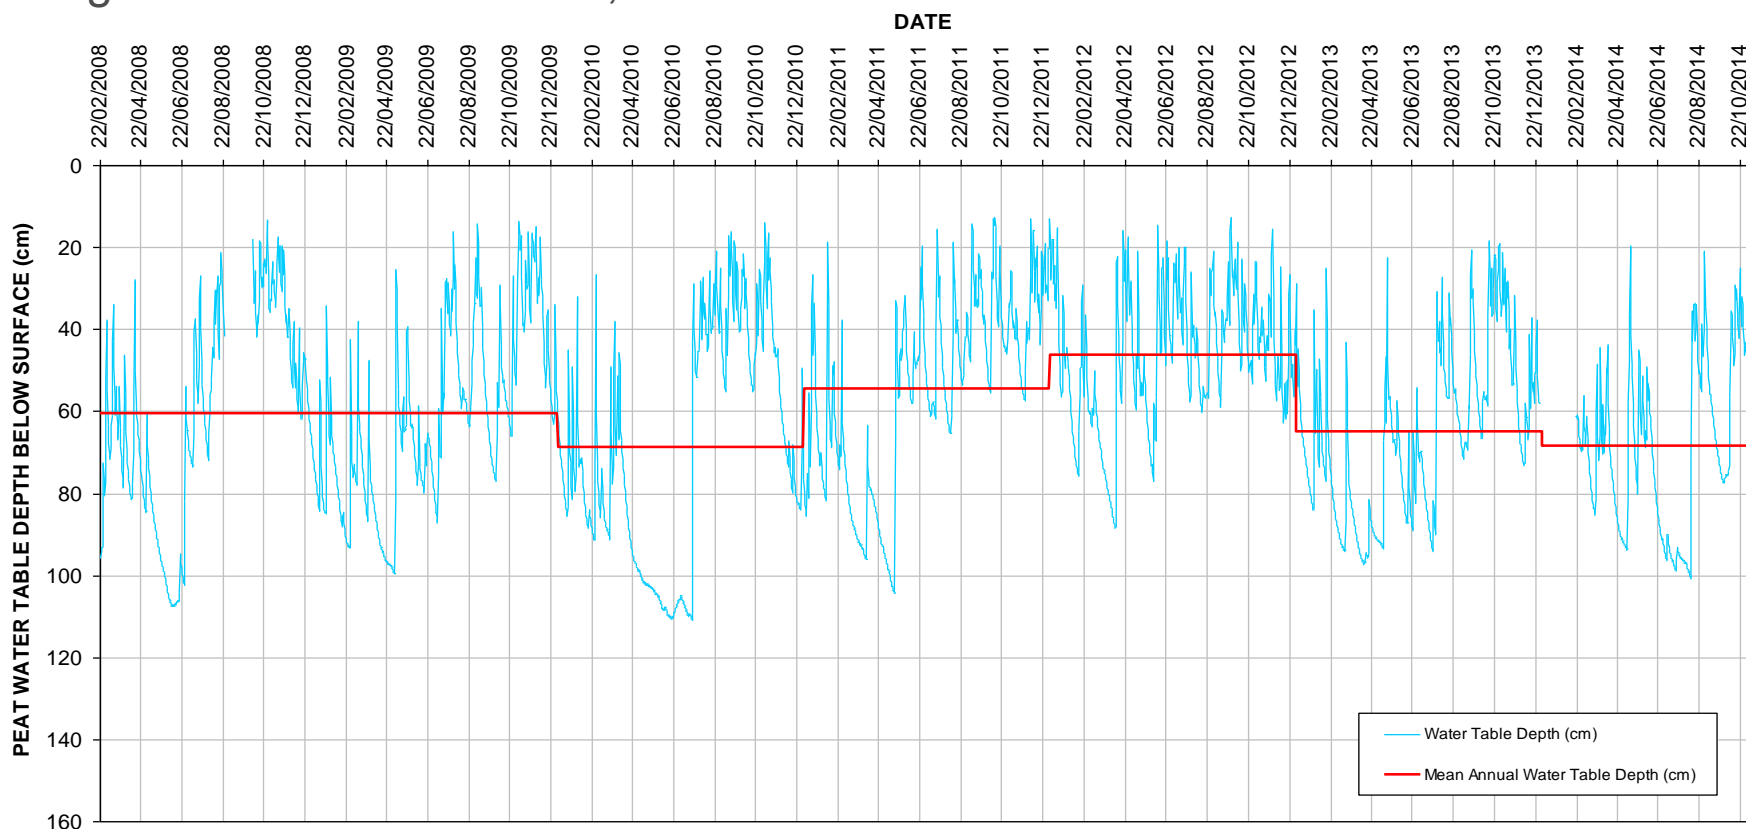
The **peat water levels at Ashway Gap** remain compromised due to highly degraded nature of the site, and vulnerable to local weather conditions.

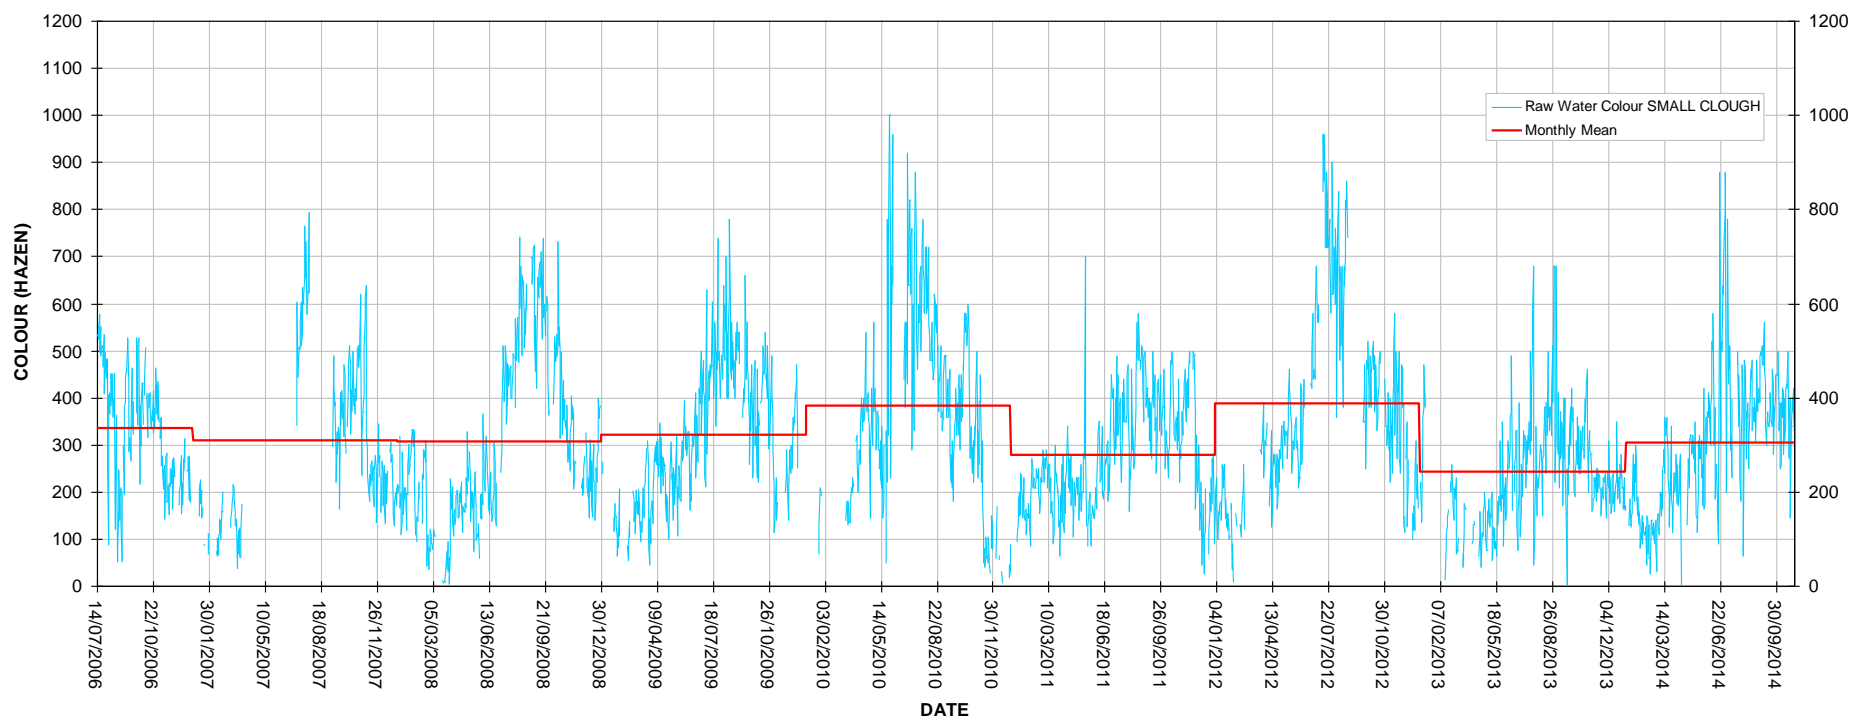
Trend towards stabilised **colour** over time at **Ashway Gap** (Small Clough), but still regularly occurring high peaks of colour generation
