# *United Utilities' SCaMP Project*

Monitoring the effects of upland habitat restoration on hydrology, water colour and carbon at three blanket bog sites

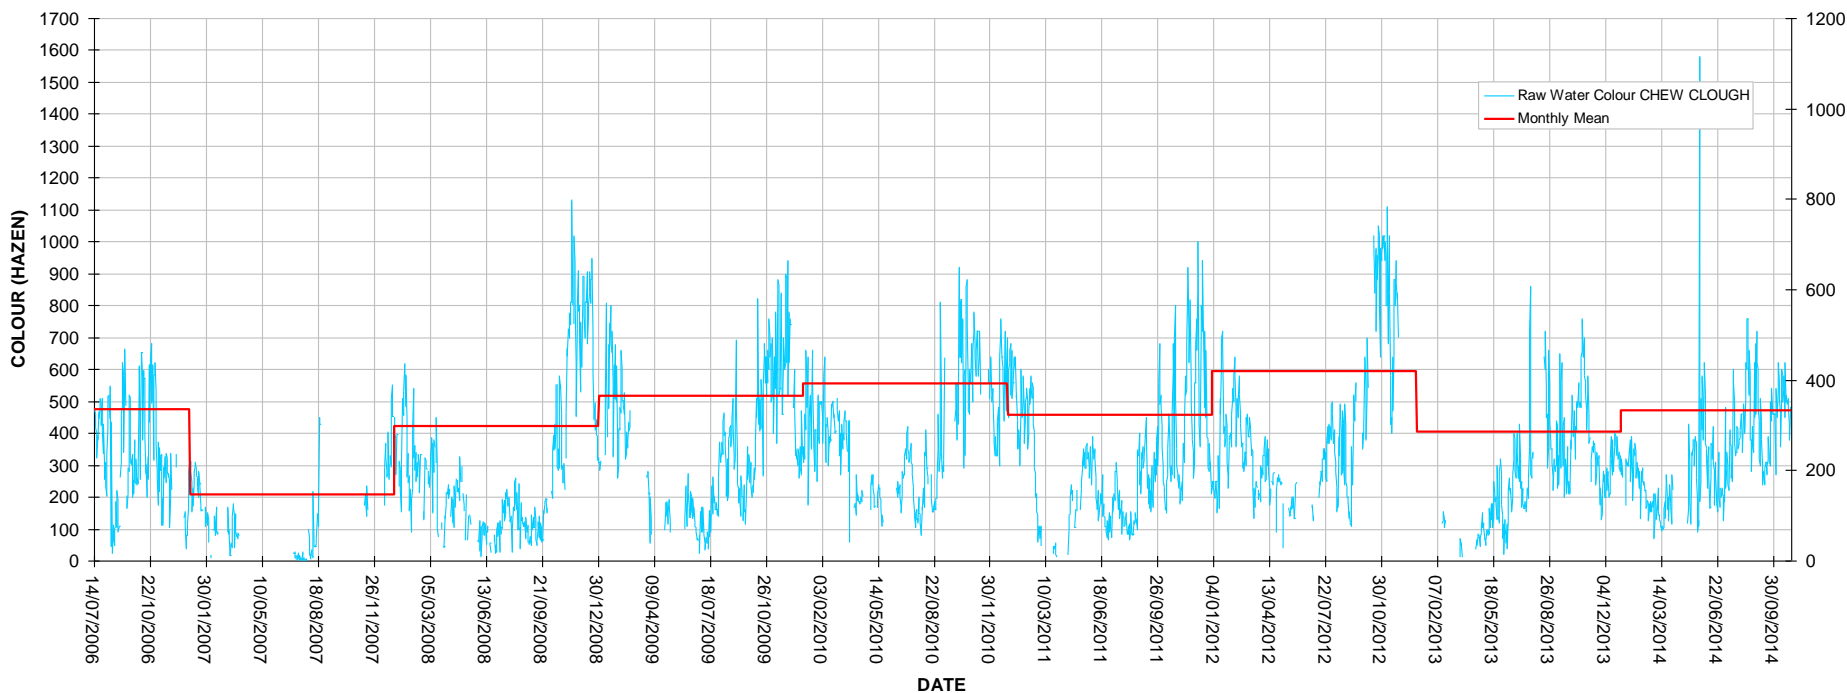
In contrast there is increasing **colour** over time at **Ashway Gap** (Chew Clough), but still regularly occurring high peaks of colour generation

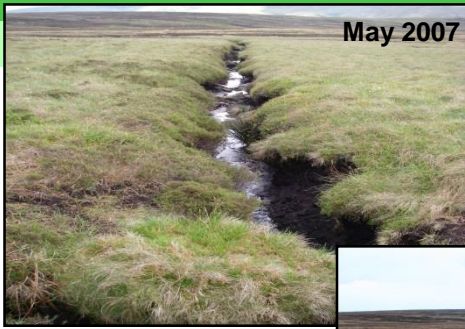
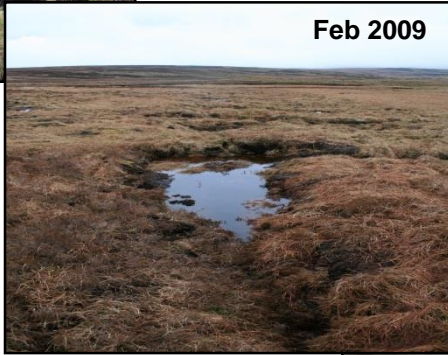
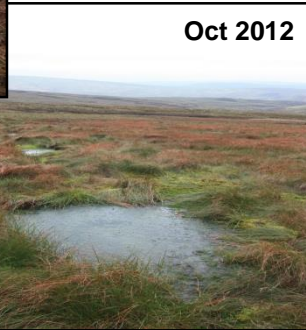
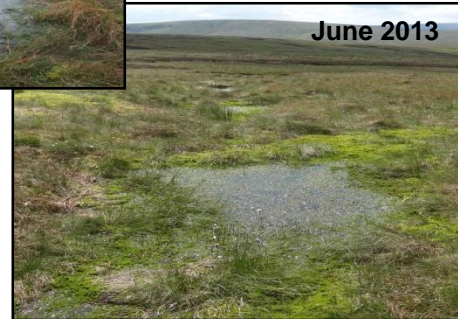
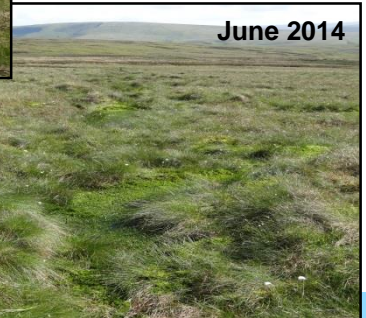
### GRIP BLOCKING EFFECTS...

- Slowing the flow
- Re-wetting of peat body
- Restoration of hydrological function
- Vegetation changes and improvements

- Raw water colour – changes in rate of colour production and release, including reductions
- Turbidity reductions/stabilisations

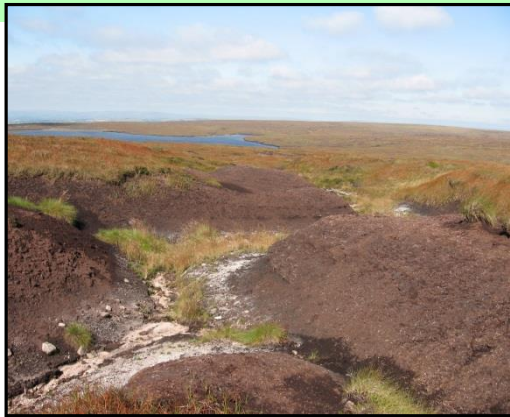
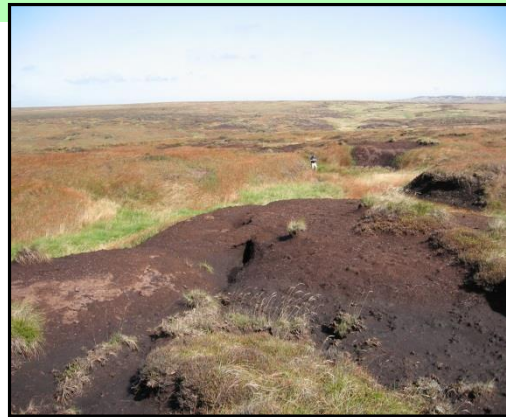
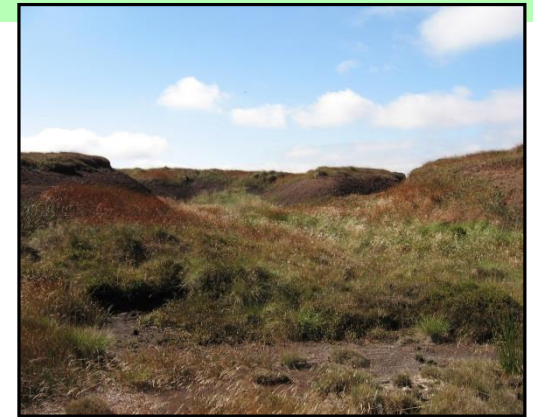
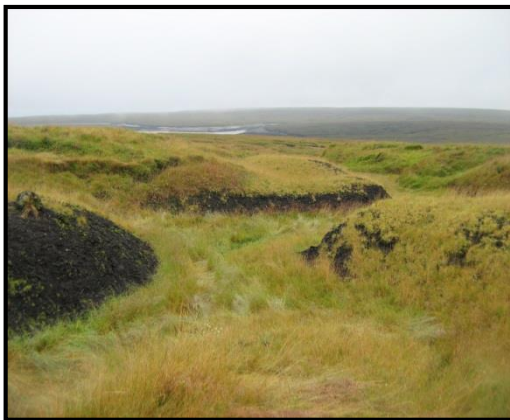
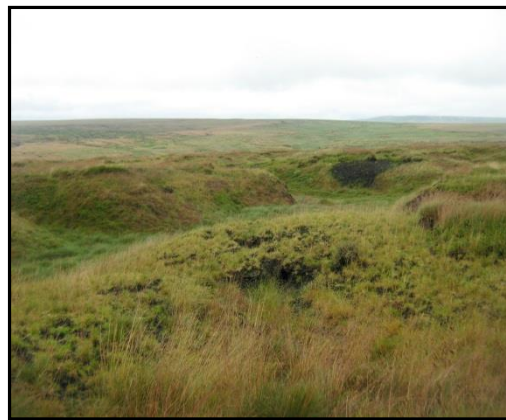
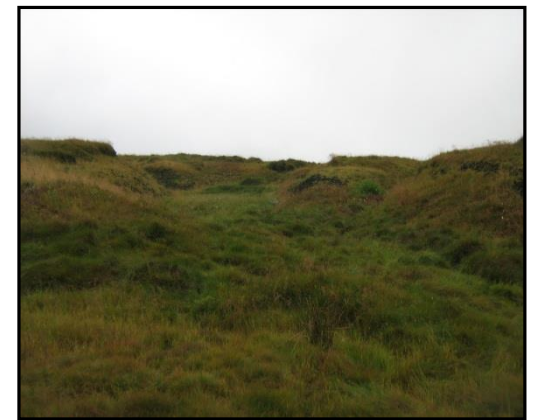
## RE-VEGETATION EFFECTS...

- Slowing the flow
- Structural changes and improvements to peat body
- Some observed re-wetting over time
- Restoration of hydrological function...?

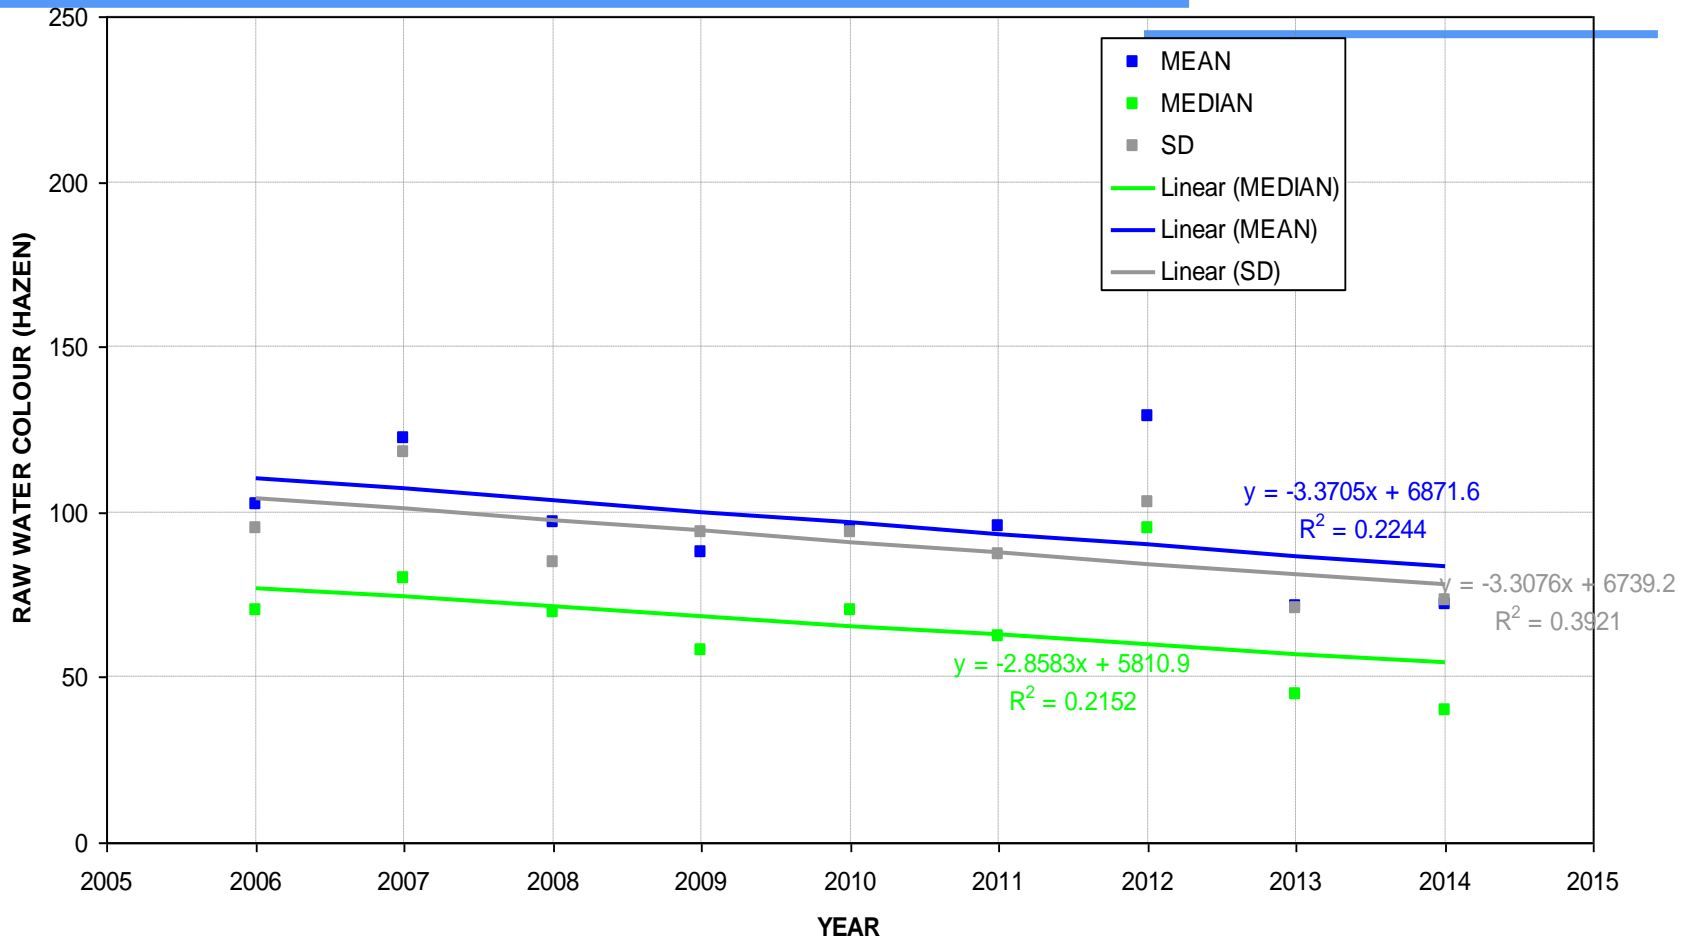
**RAW STREAMWATER COLOUR TRAJECTORY FOR RIVER GOYT,  
BASED ON MEAN ANNUAL DATA (2006-2014)**

In the latest SCaMP report, trajectories of raw water colour have been compared to the colour trend at the UK Upland Waters Monitoring Network on the River Etherow in Derbyshire, in order to gauge the magnitude and direction of colour trends on the SCaMP catchments.

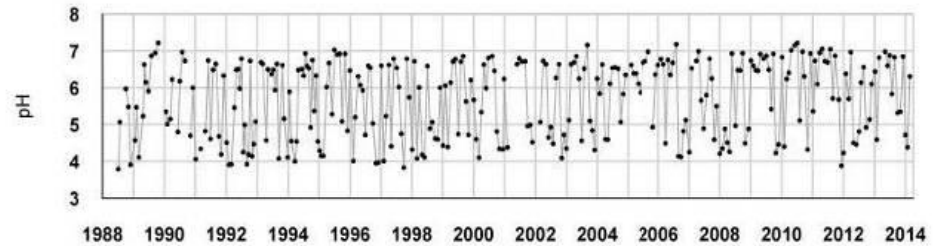
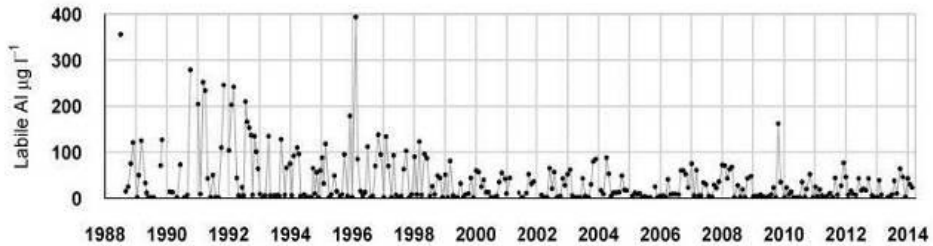
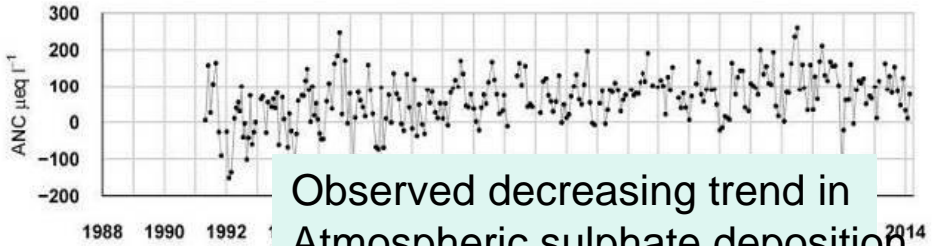
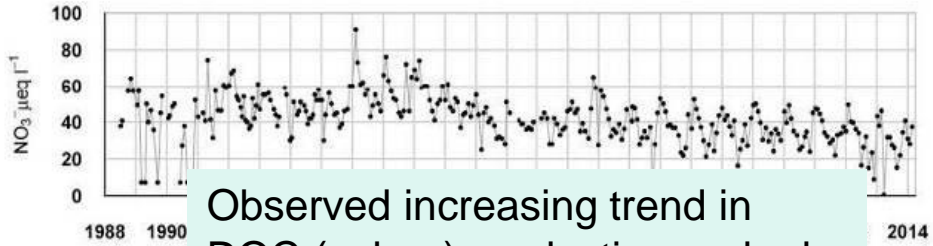
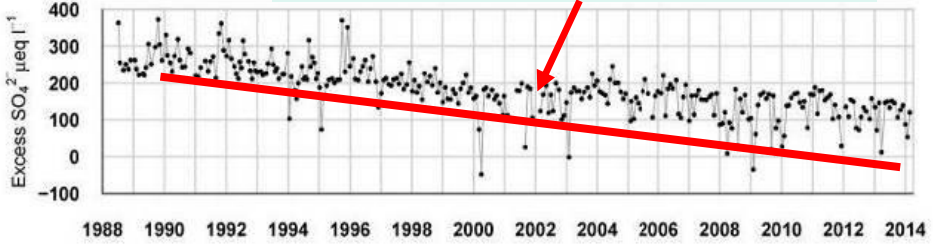
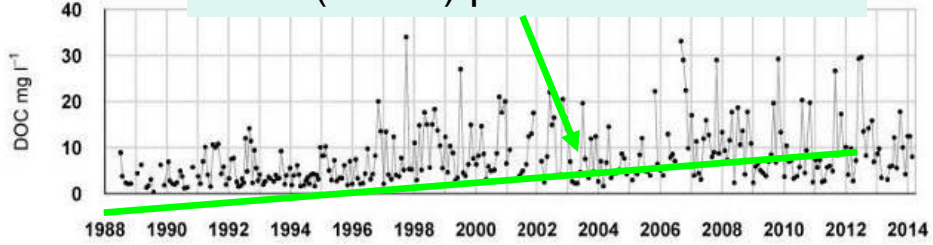
Stream water chemistry trends for baseline UK UWMN site on the River Etherow at Woodhead, Derbyshire

Observed decreasing trend in Atmospheric sulphate deposition

Observed increasing trend in DOC (colour) production and release
