# **CATCHMENT MANAGEMENT OF WATER COLOUR & ITS TREATMENT :**

## Water colour in the Pennines

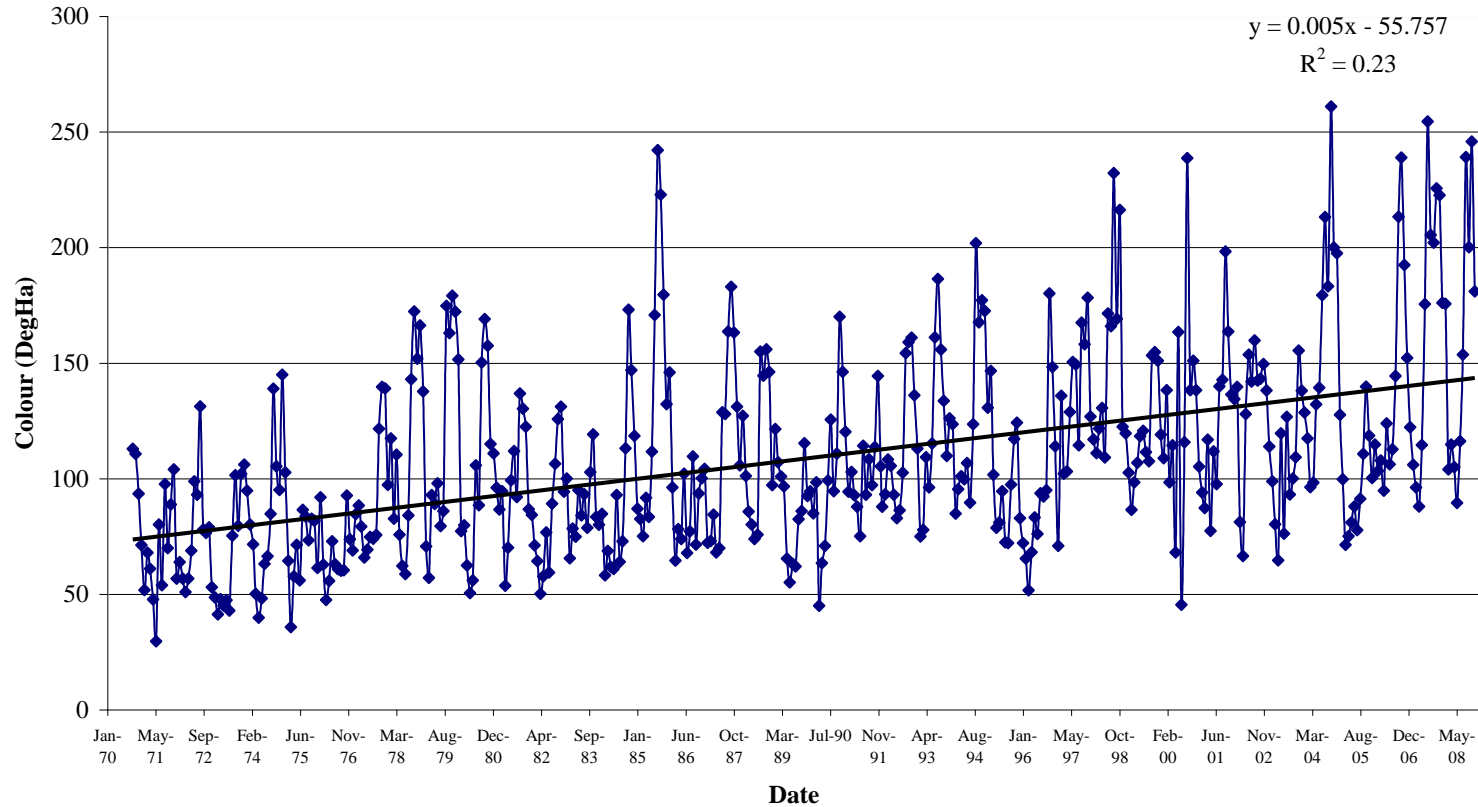
Broken Scar- Raw water colour on River Tees 1970-2008 from monthly average results

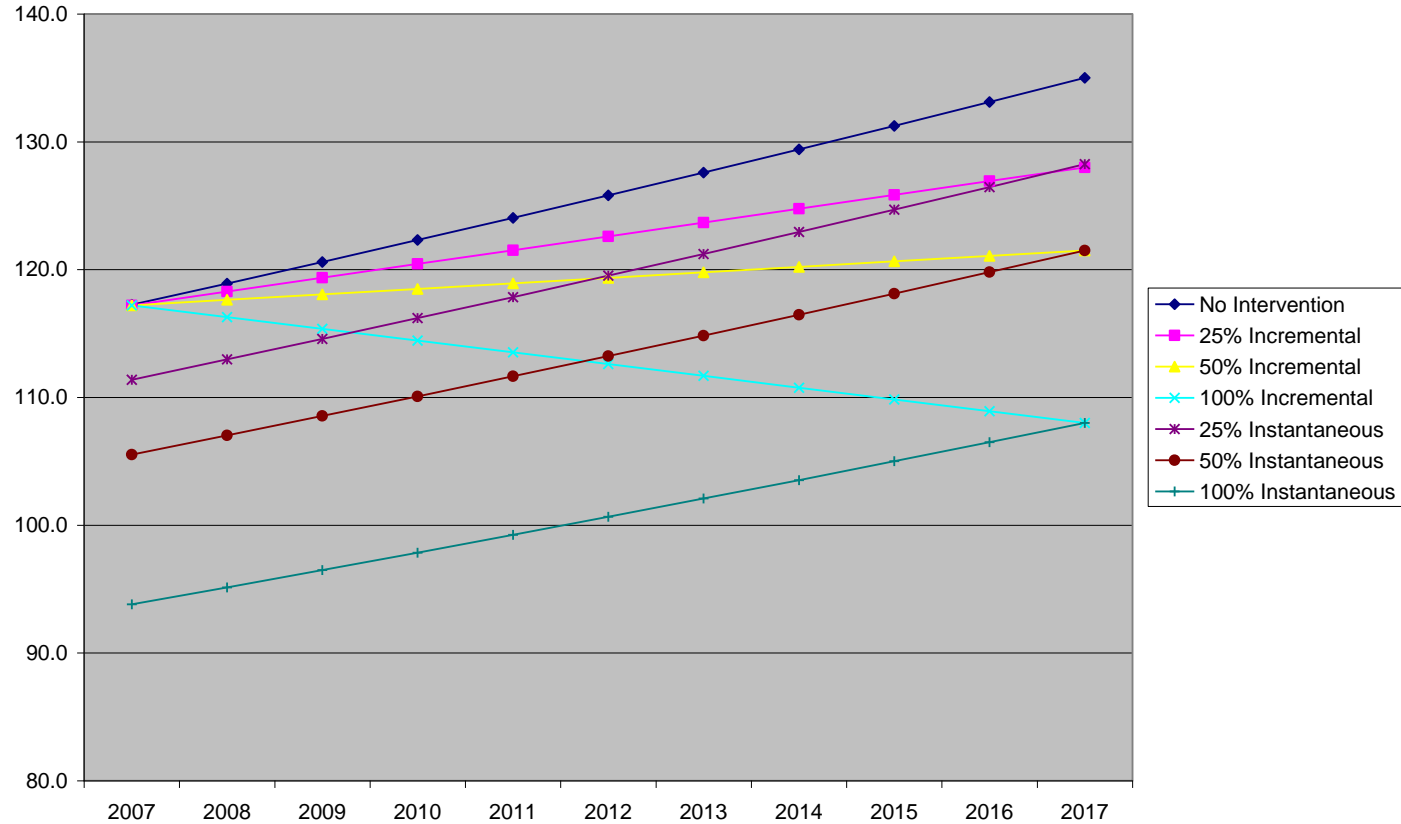
# ***PREDICTED COLOUR CHANGES AT BROKEN SCAR WITH VARIOUS PROPORTIONS OF GRIP BLOCKING (2007 – 2017)***

The graph shows changes in colour at Broken Scar under each grip blocking scenario. Similar trends are produced for 5% and 6% DOC increases, however these show a lower rate of colour increase

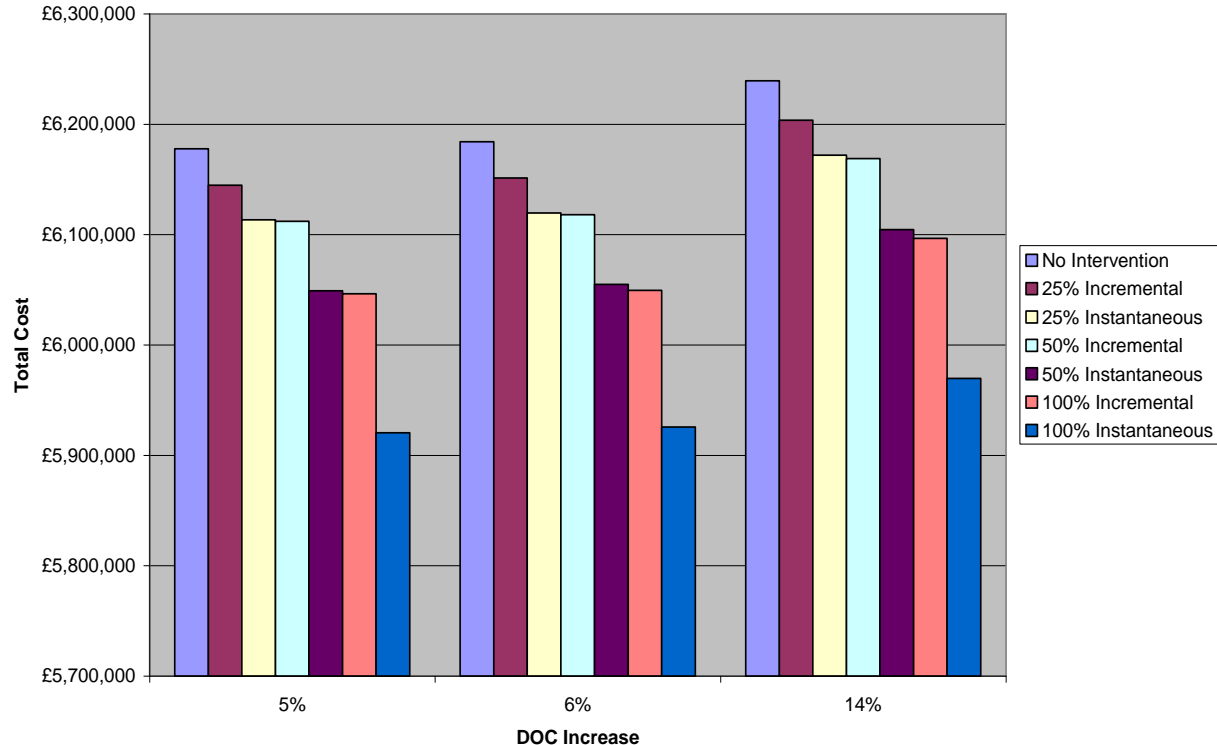
## TOTAL COAGULANT AND SLUDGE COSTS FOR 10 YEARS 2007-2017 UNDER EACH SCENARIO

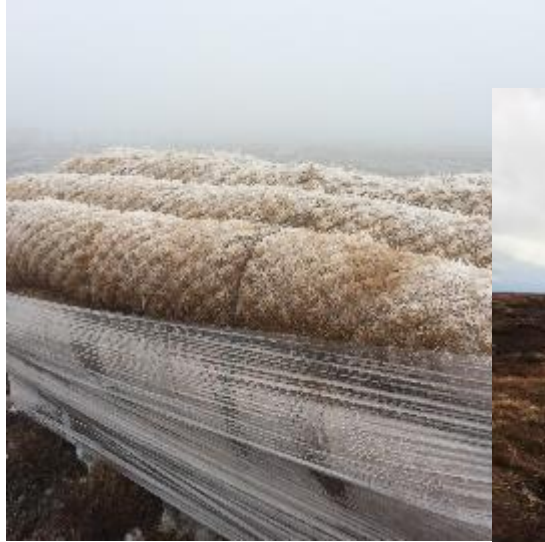
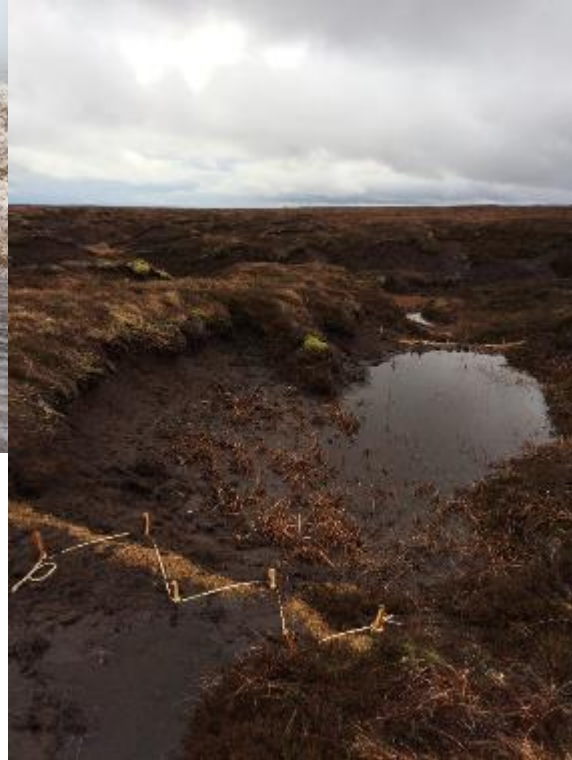
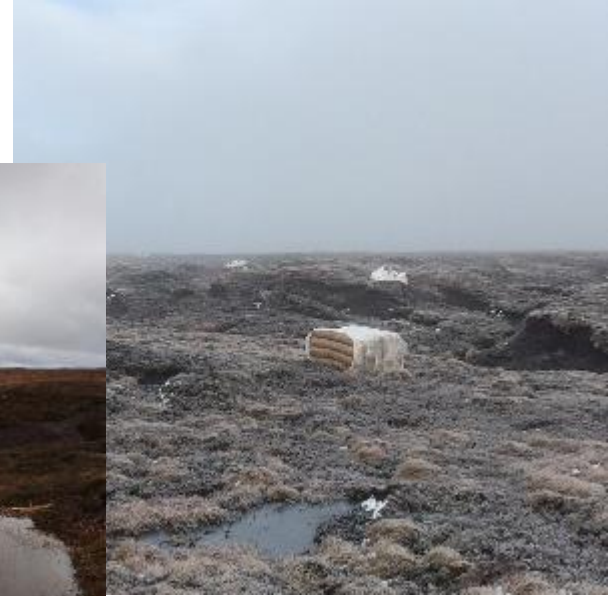
## COIR ROLLS

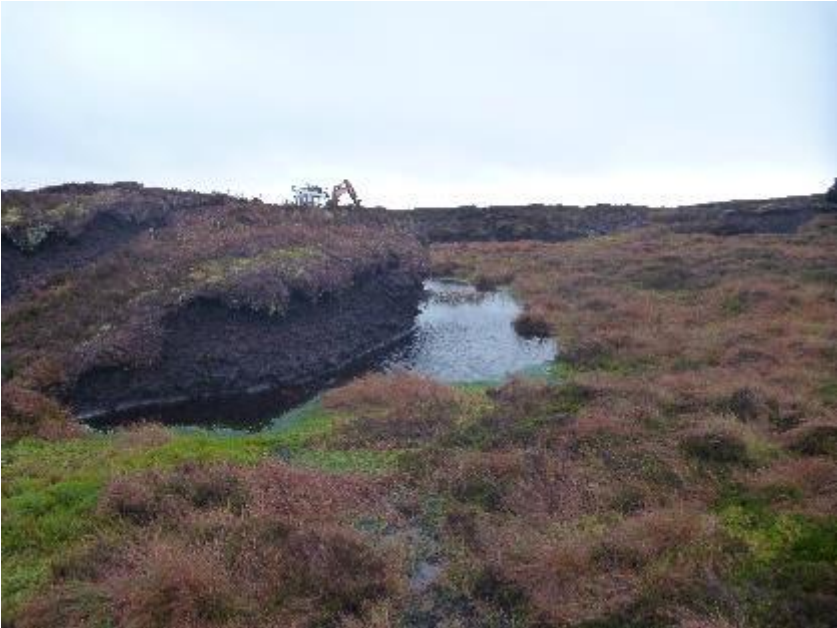
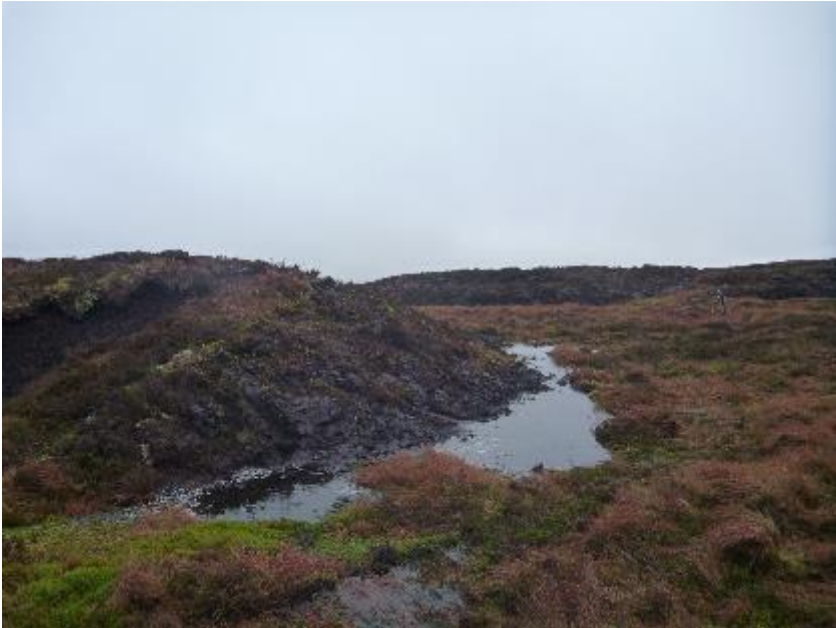
# NWG PEATLAND PROJECTS RE-PROFILING

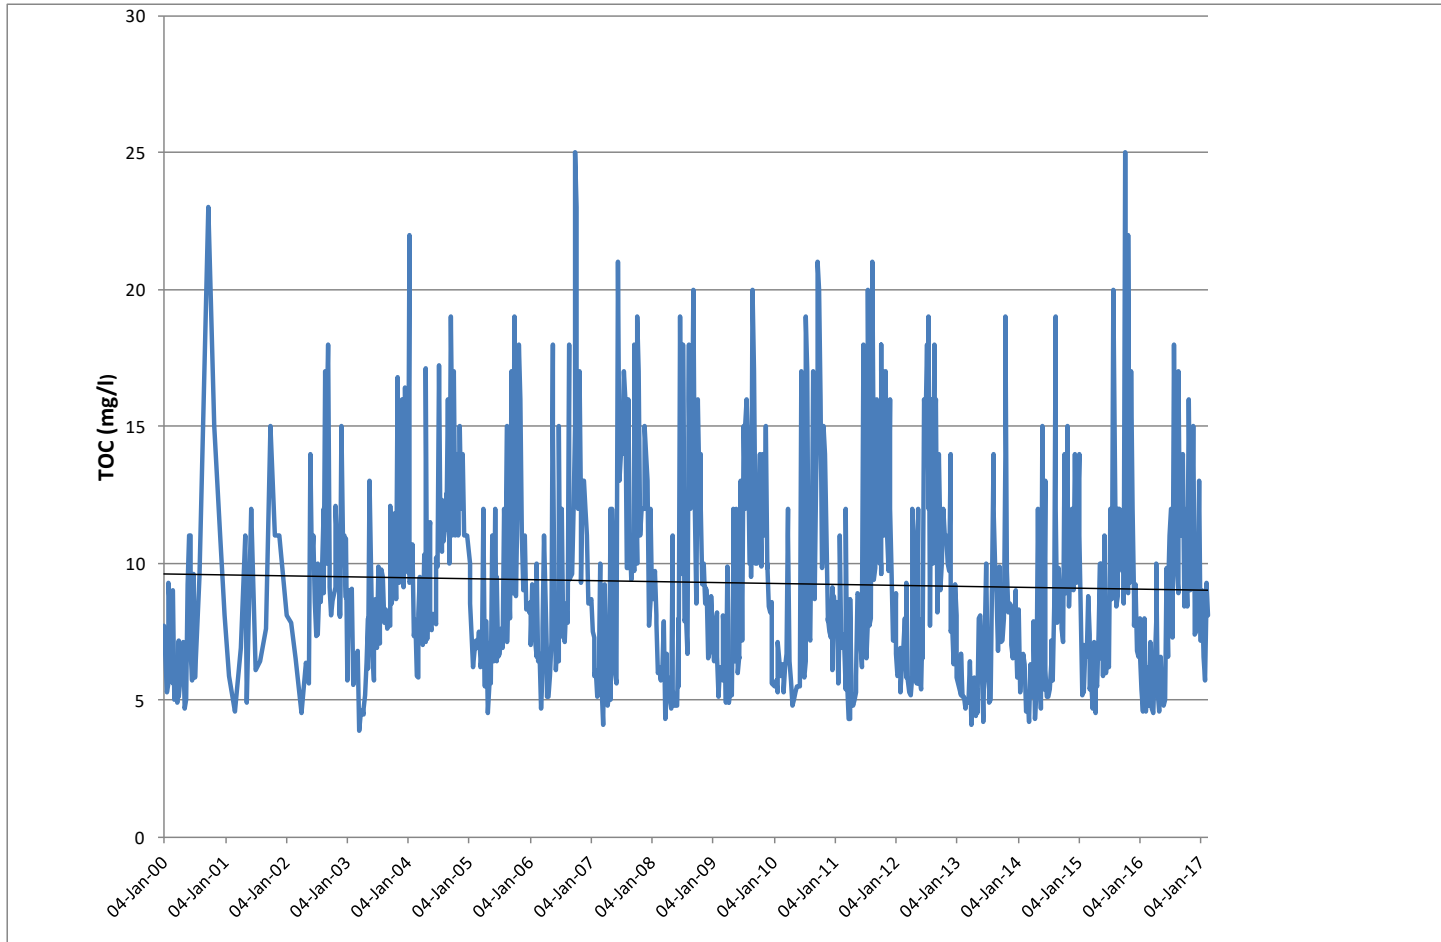
## TOTAL ORGANIC CARBON 2000-2017
