# Collaborative research on underground infrastructure

*IKT – Institute for Underground Infrastructure*

## IKT Compare „Short Liner for House Connections“

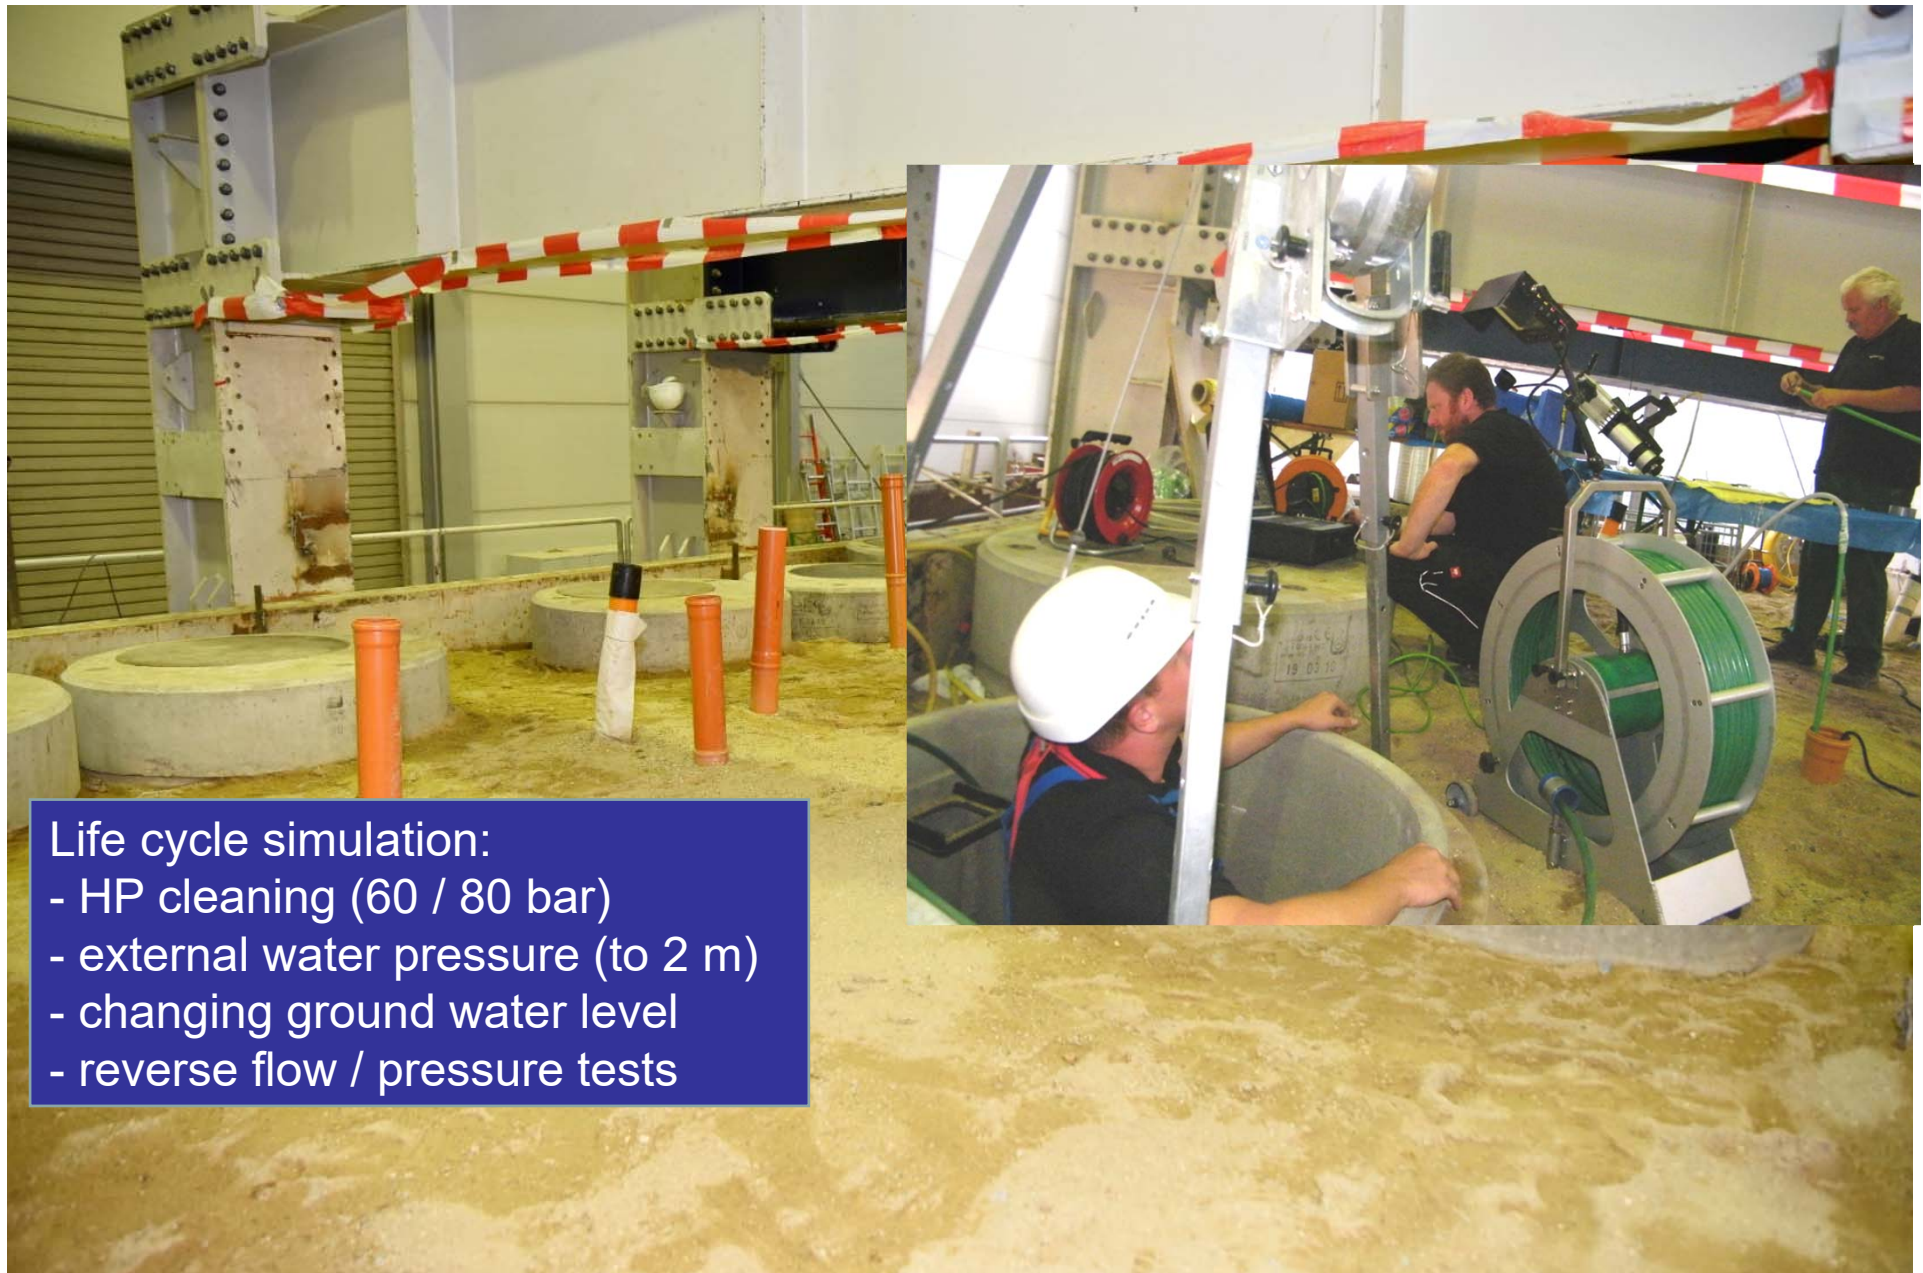
# Experimental set-up

- Life cycle simulation:
- HP cleaning (60 / 80 bar)
  - external water pressure (to 2 m)
  - changing ground water level
  - reverse flow / pressure tests

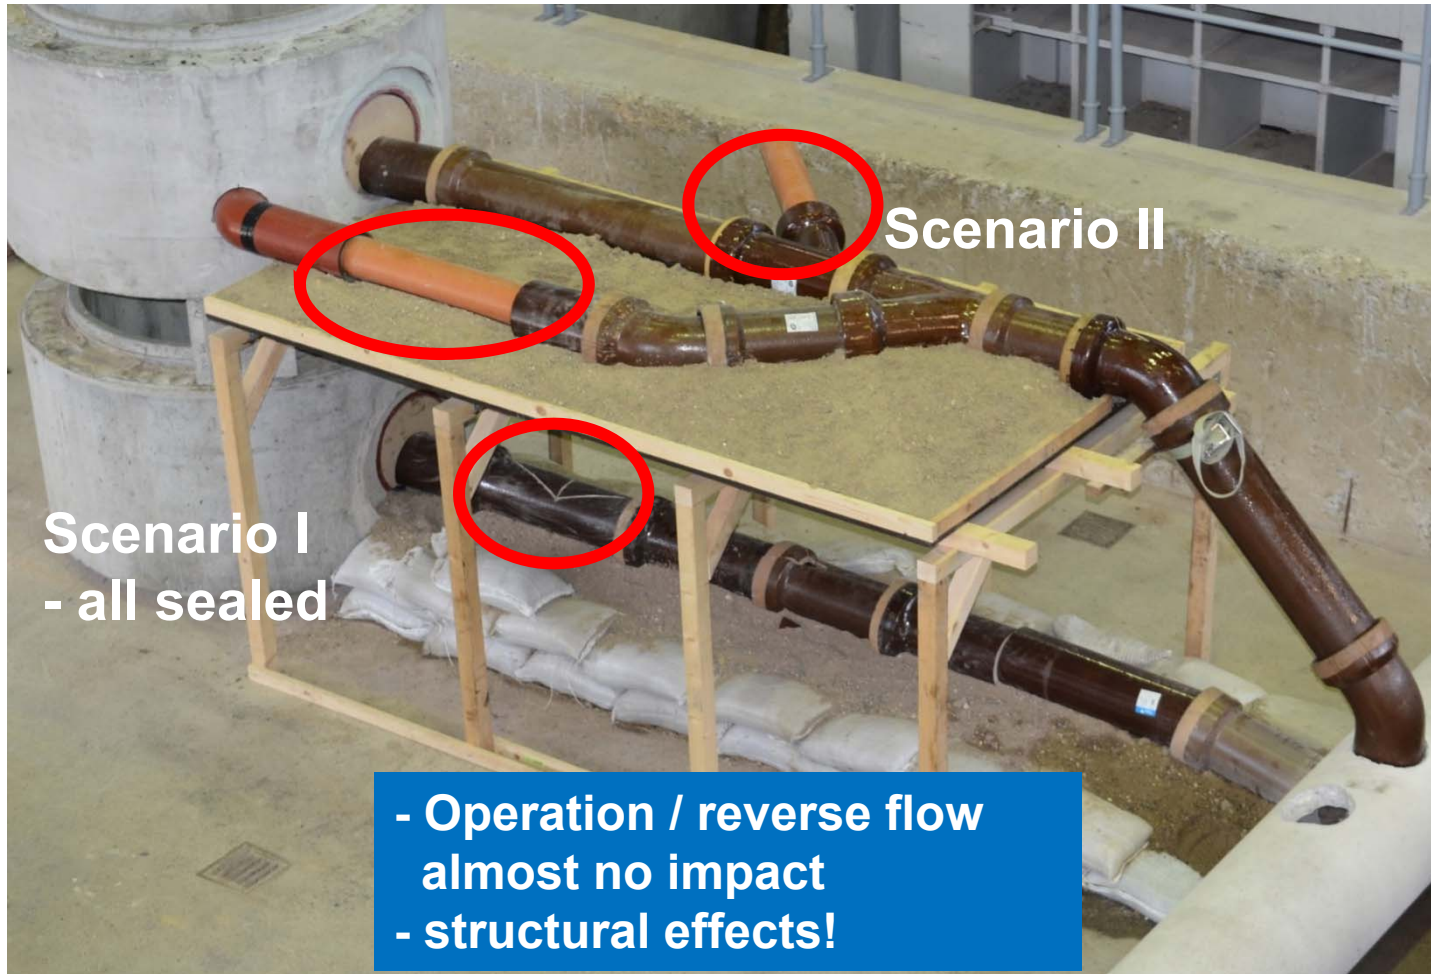
# Test results, example

Scenario I  
- all sealed

Scenario II

- Operation / reverse flow  
almost no impact  
- structural effects!
